**SUPPLEMENTAL WATERSHED PLAN NO. VII &  
ENVIRONMENTAL ASSESSMENT  
FOR THE REHABILITATION OF FLOODWATER RETARDING STRUCTURE NO. 25  
OF THE UPPER BRUSHY CREEK WATERSHED**

**Prepared by:**  
U.S. Department of Agriculture  
Natural Resources Conservation Service

January 2025

**Draft**  
**Supplemental Watershed Plan No. VII and Environmental Assessment**  
**for the**  
**Rehabilitation of Floodwater retarding Structures No. 25**  
**of the**  
**Upper Brushy Creek Watershed**  
**Williamson County, Texas**

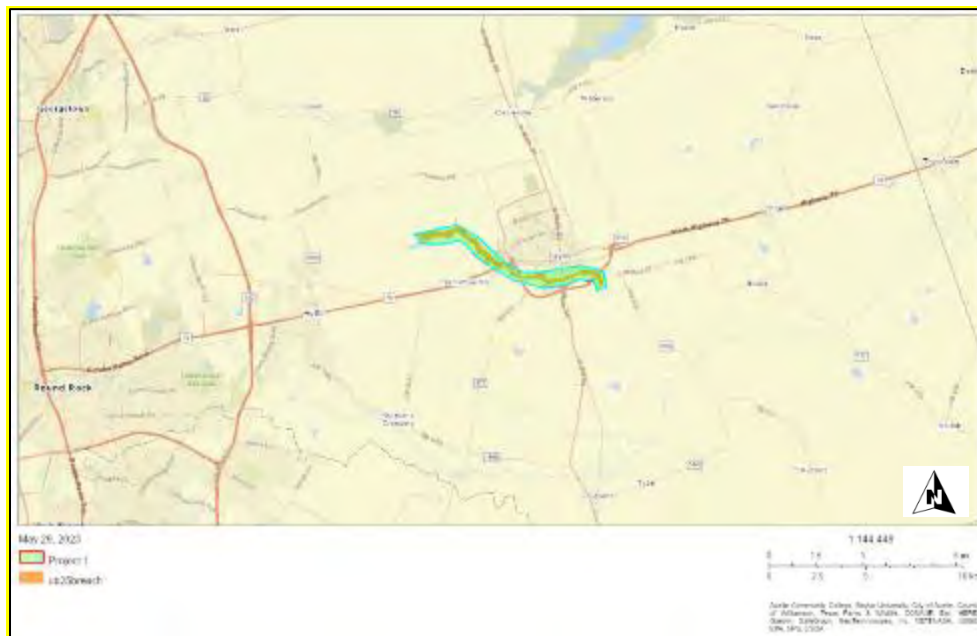
**Figure 1. Area Evaluation (Breach Inundation Zone) for Environmental Justice Effects**

An environmental justice and civil rights analysis was conducted for the breach inundation zone and associated nearby areas downstream of Upper Brushy Creek FRS No. 25 (Figure 1 and Table F). EPA’s “EJSCREEN” tool and USDA’s Departmental Regulation 5600-02, Environmental Justice, were used to

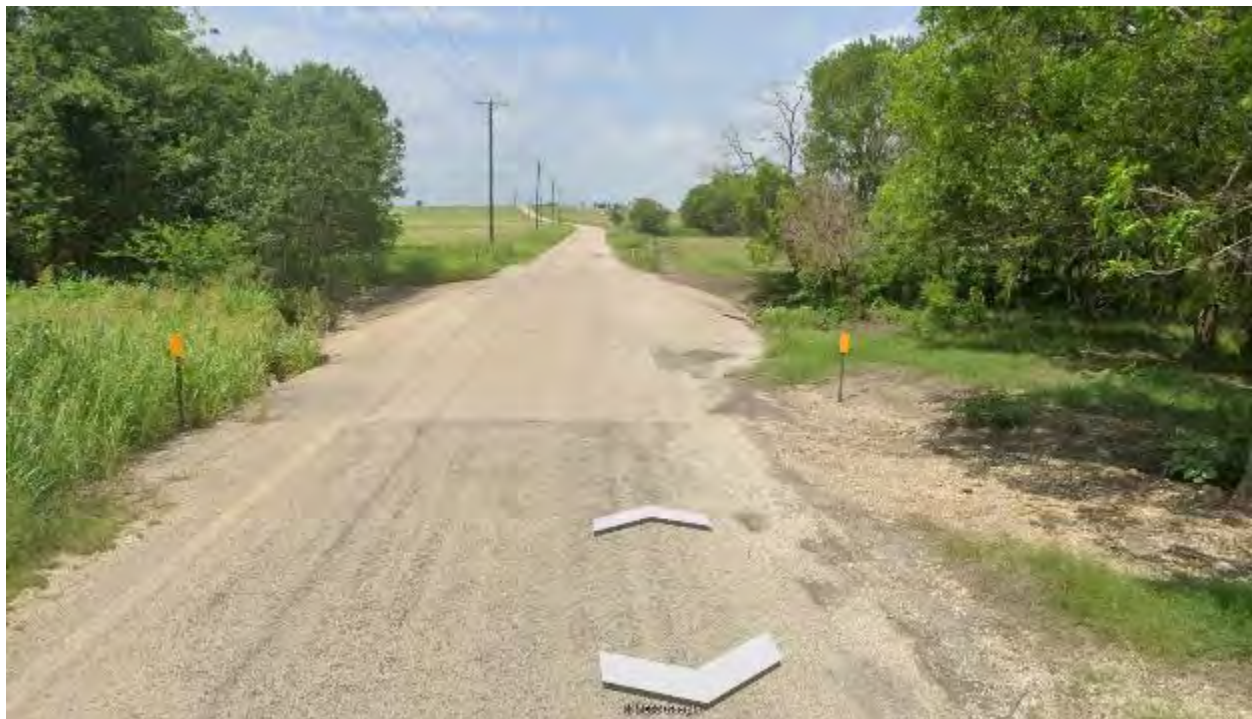
**Figure 2 County Road 398 would be inundated by about 7.6 feet of floodwaters during a breach of Upper Brushy Creek FRS No. 25**

One residence, two outbuildings, and three airport structures as well as motorists on County Road 398, US Highway 79, Airport Road, Welch Street, and W Rio Grande Street would be at risk in the event of a breach. Vehicles on the roads would be washed downstream, and the road surfaces would be damaged and impassable. Traffic would be disrupted for an extended time while the roadways were being repaired. Given the number of properties and vehicles located within the breach zone, it is estimated that the number of people at risk due to a breach of FRS No. 25 would be 101. Table G shows the effects of a breach of FRS No. 25 on downstream properties and crossings (Figure 2 through Figure 7).

Downstream Properties/Crossings	Depth Above First Floor Elevation (ft)	Depth Over Crossing (ft)	Daily Traffic Count	Maximum Velocity (ft/s)
1 residences	≤ 1	-	-	-
2 barns/outbuildings	≤ 1	-	-	-
3 Airport Structures	≤ 5	-	-	-
County Road 398	-	8.1	193	7.6
US Highway 79	-	1.4	26,743	2.2
Airport Road	-	0.6	255	0.2
Welch Street	-	3.5	31	9.0
US Highway 79	-	1.8	14,615	1.0
West Rio Grande Street	-	8.5	N/A*	4.1

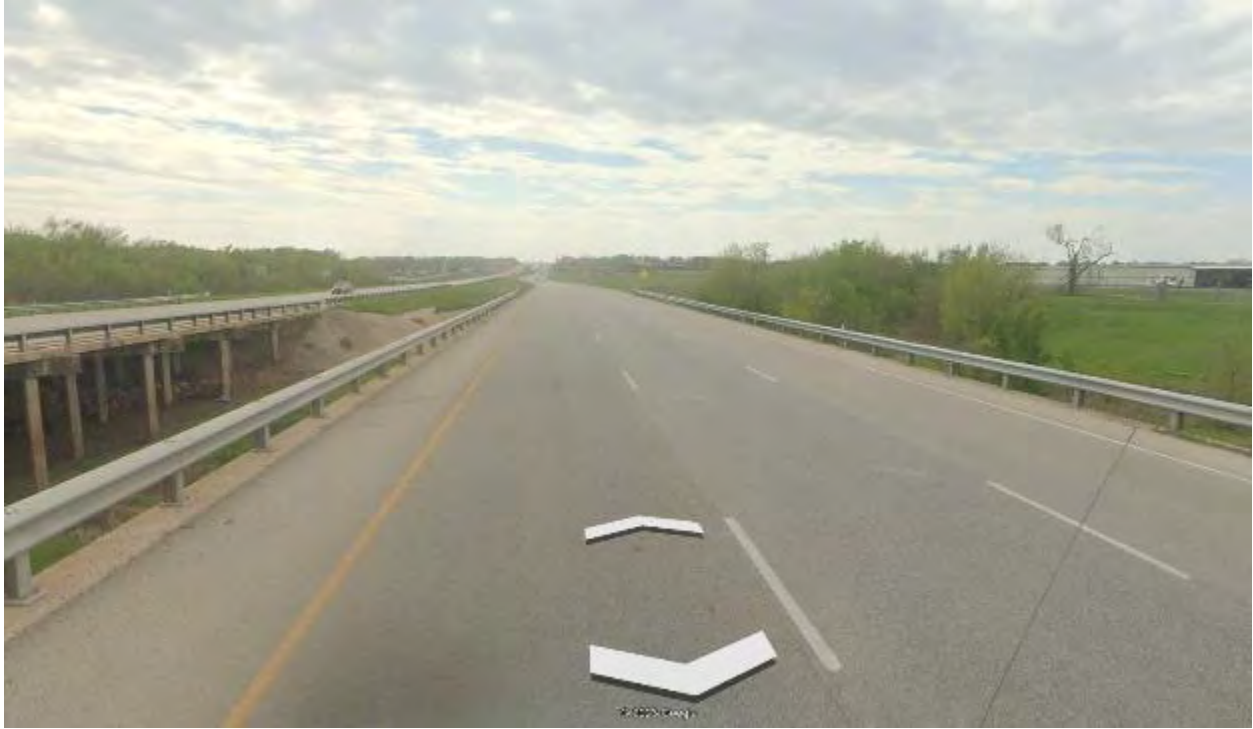
**Figure 3 US Highway 79 would be inundated by about 1.5 feet of floodwaters during a breach of Upper Brushy Creek FRS No. 25**

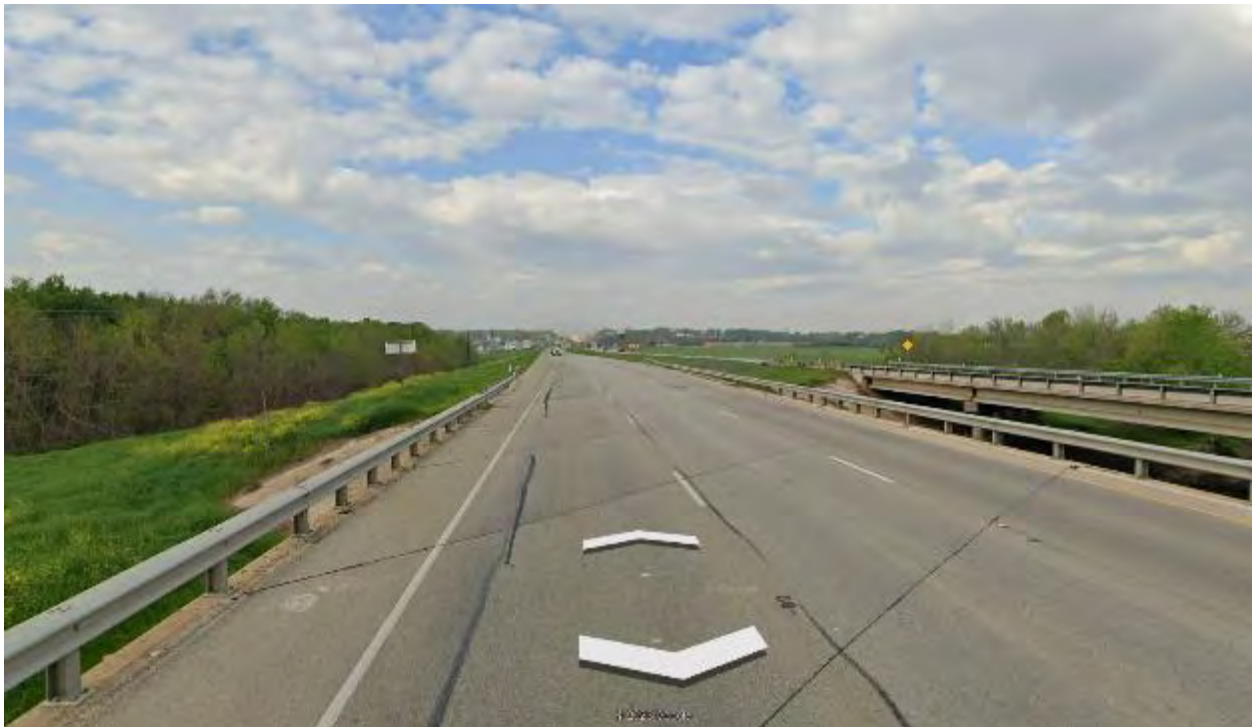
**Figure 4 US Highway 79 would be inundated by about 0.3 feet of floodwaters during a breach of Upper Brushy Creek FRS No. 25**

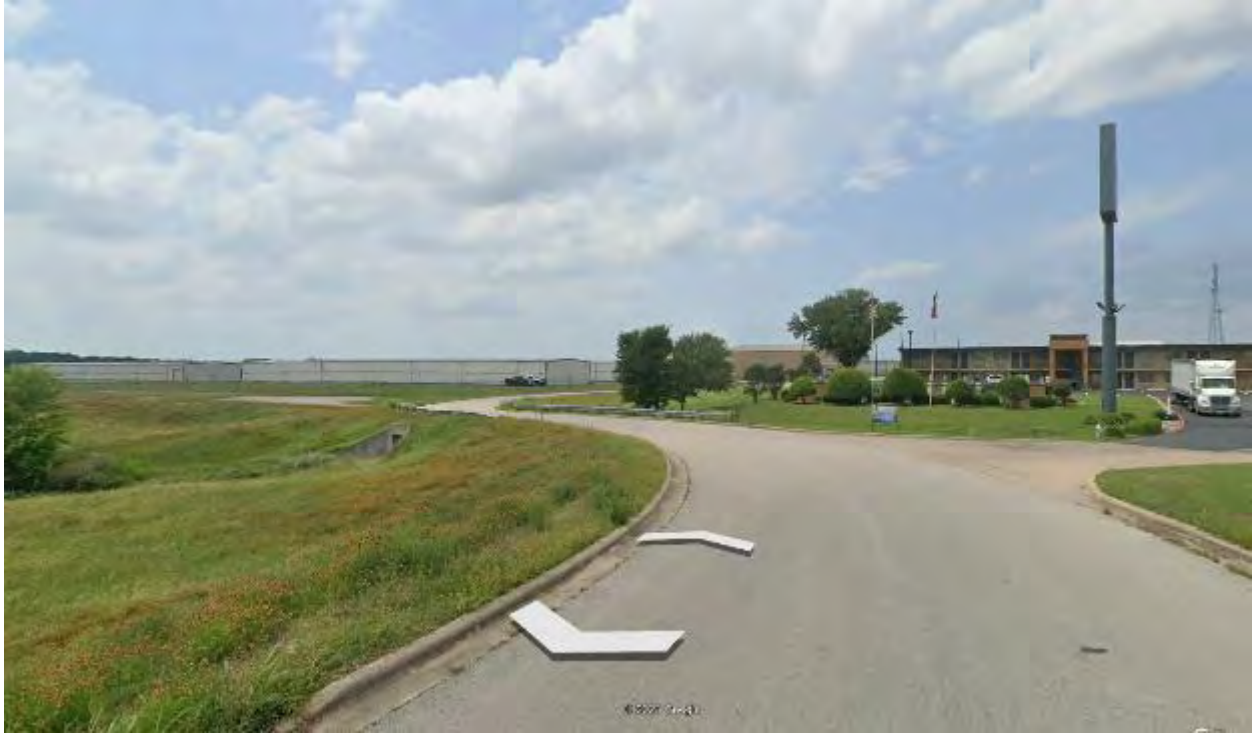
**Figure 5 Airport Road would be inundated by about 0.8 feet of floodwaters during a breach of Upper Brushy Creek FRS No. 25**

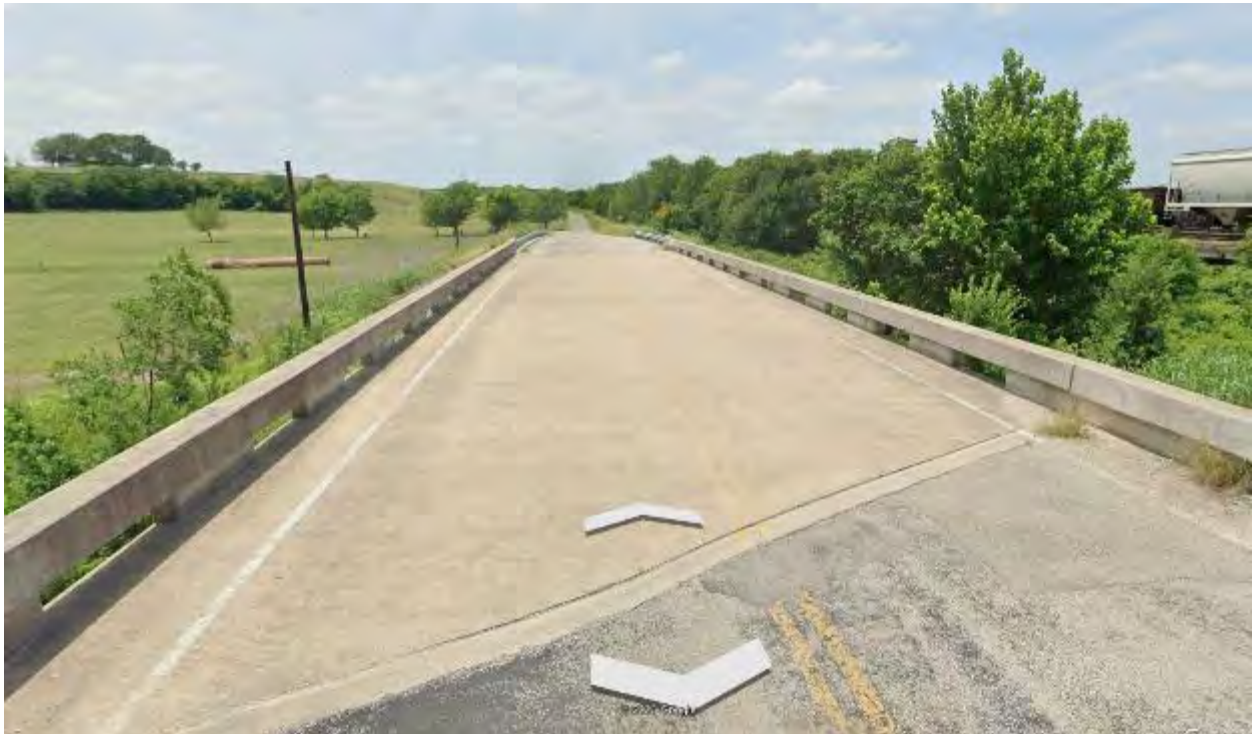
**Figure 6 Welch Street would be inundated by about 3.5 feet of floodwaters during a breach of Upper Brushy Creek FRS No. 25**

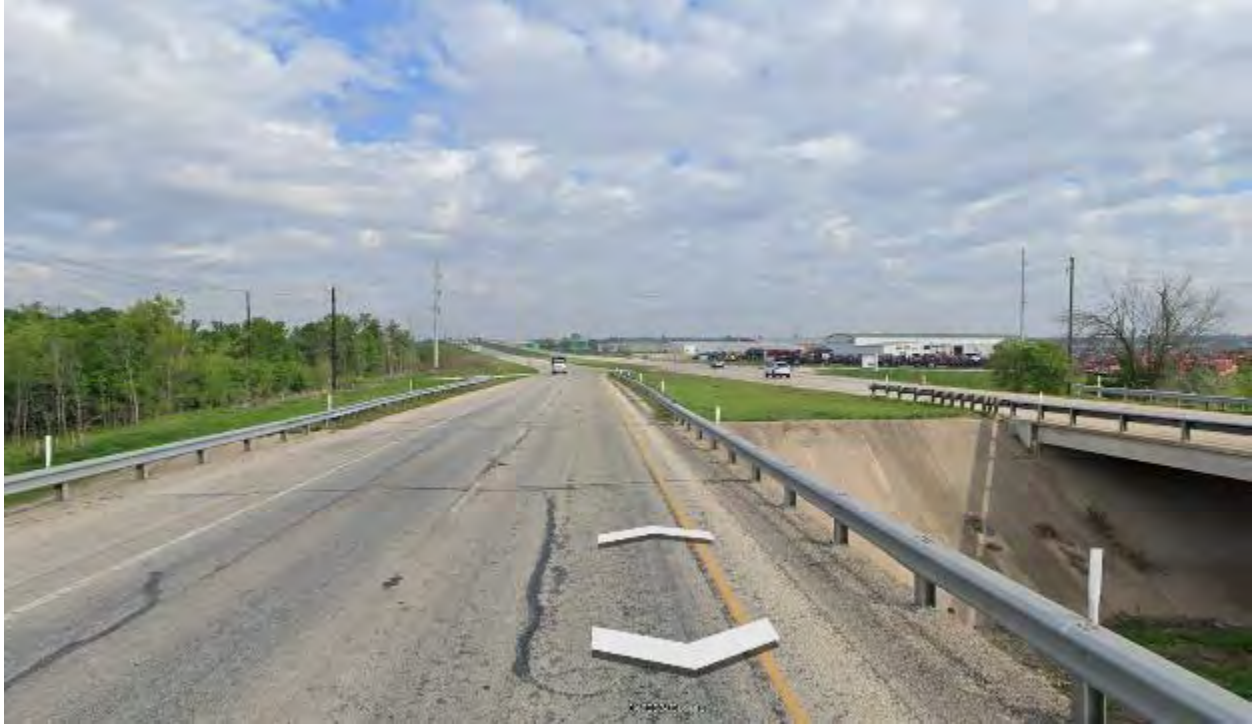
**Figure 7 US Highway 79 would be inundated by about 2.7 feet of floodwaters during a breach of Upper Brushy Creek FRS No. 25**

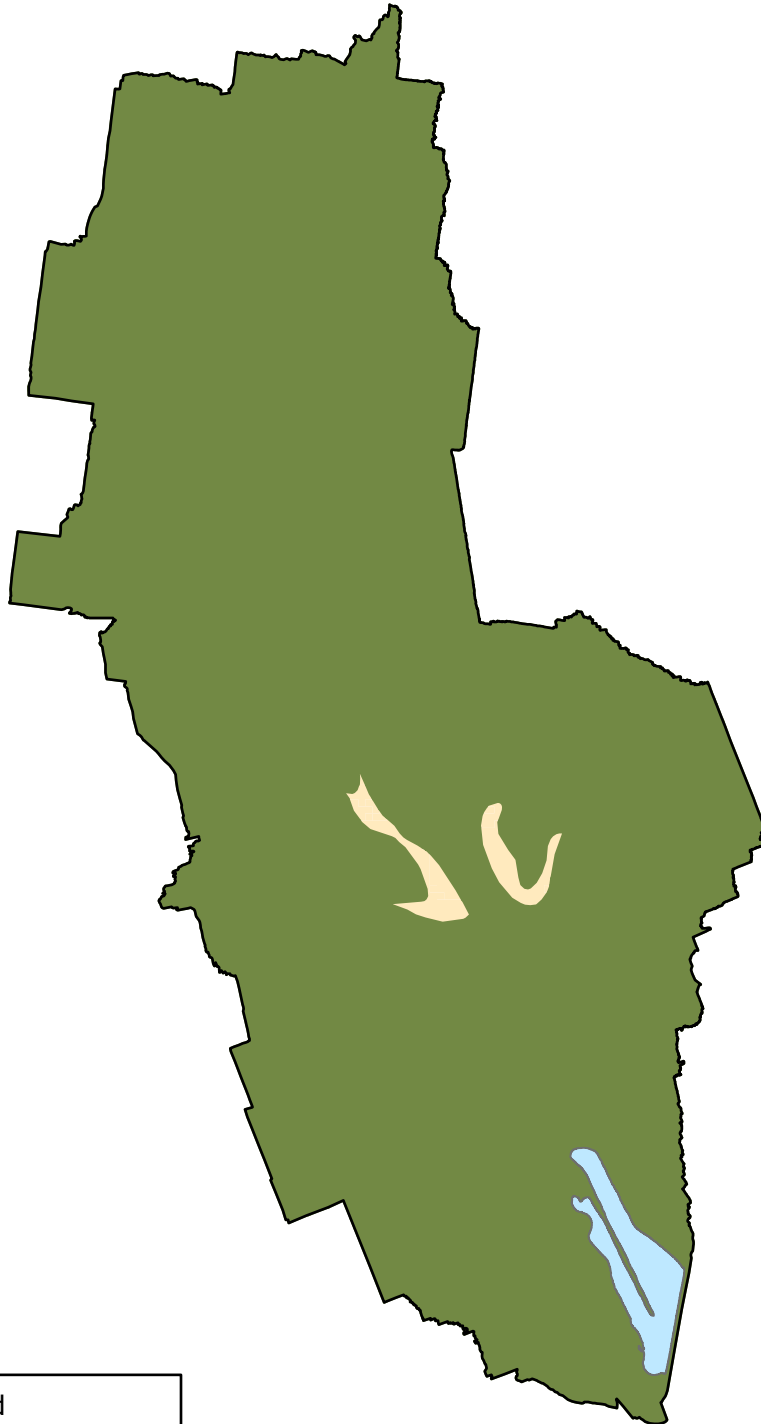
Total Watershed Area = 3.82 sq. miles

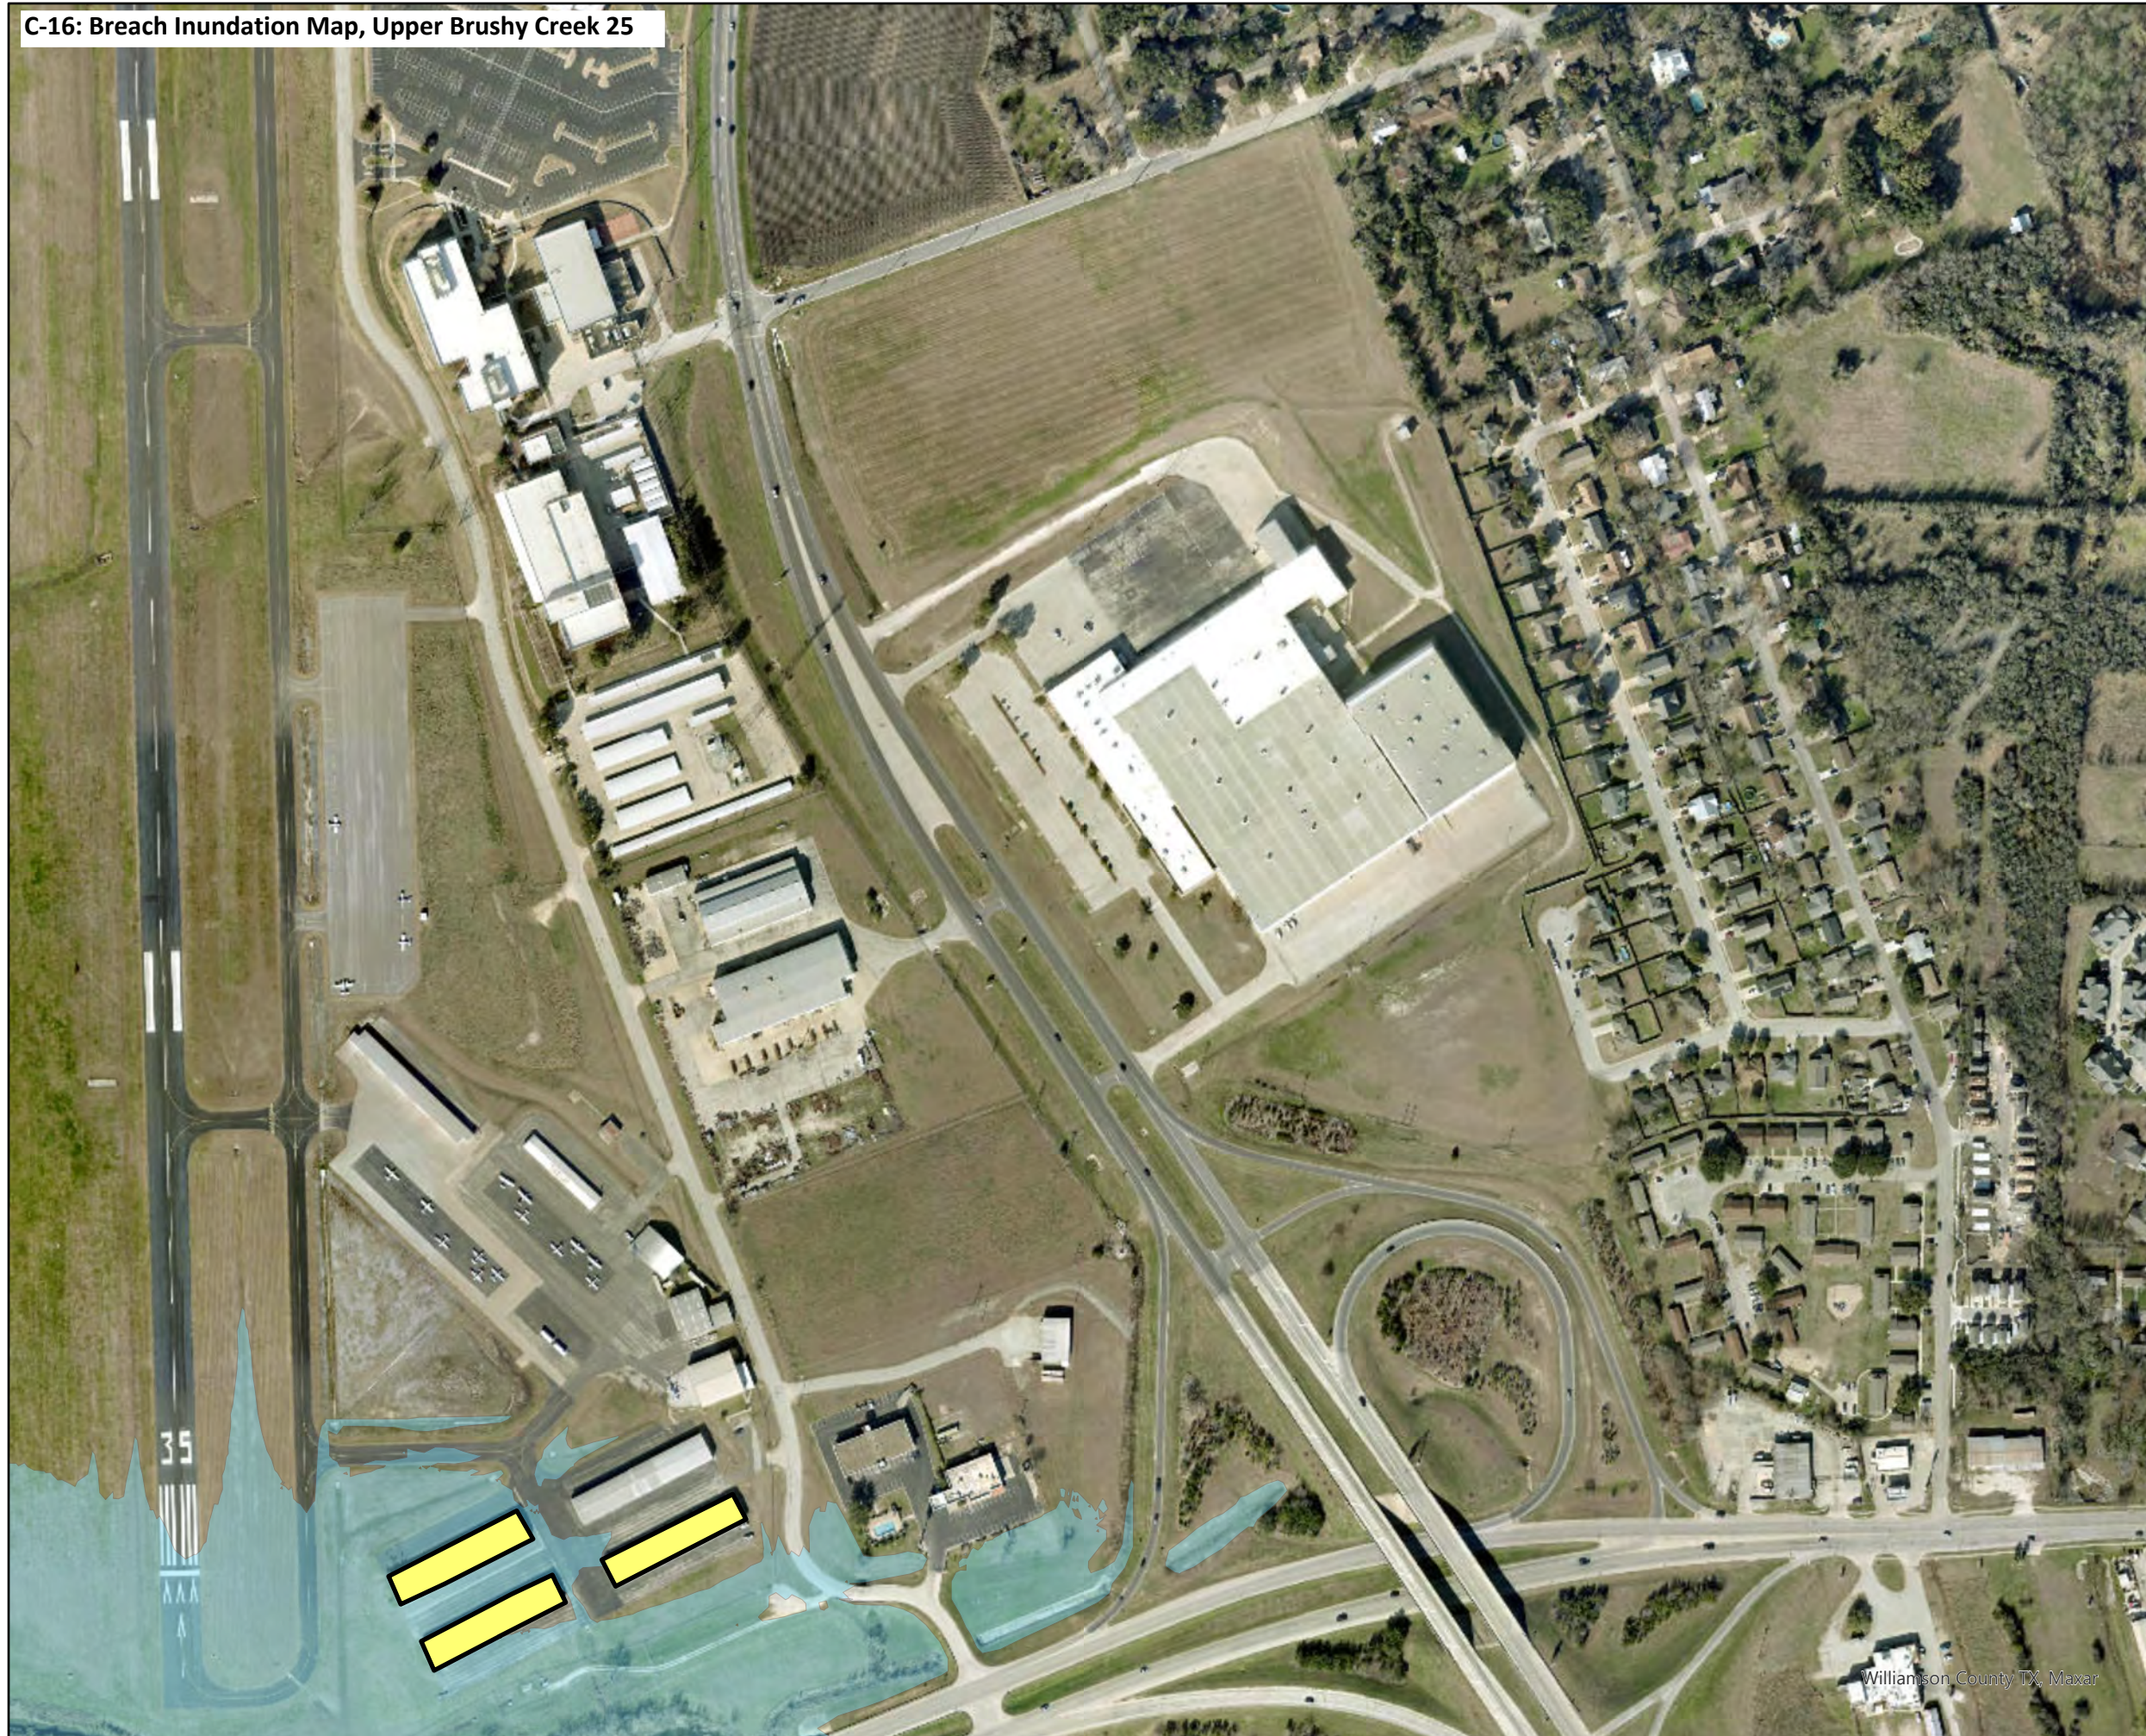
Panel 7 of 11

# UPPER BRUSHY CREEK 25 DAM FAILURE MAPPING

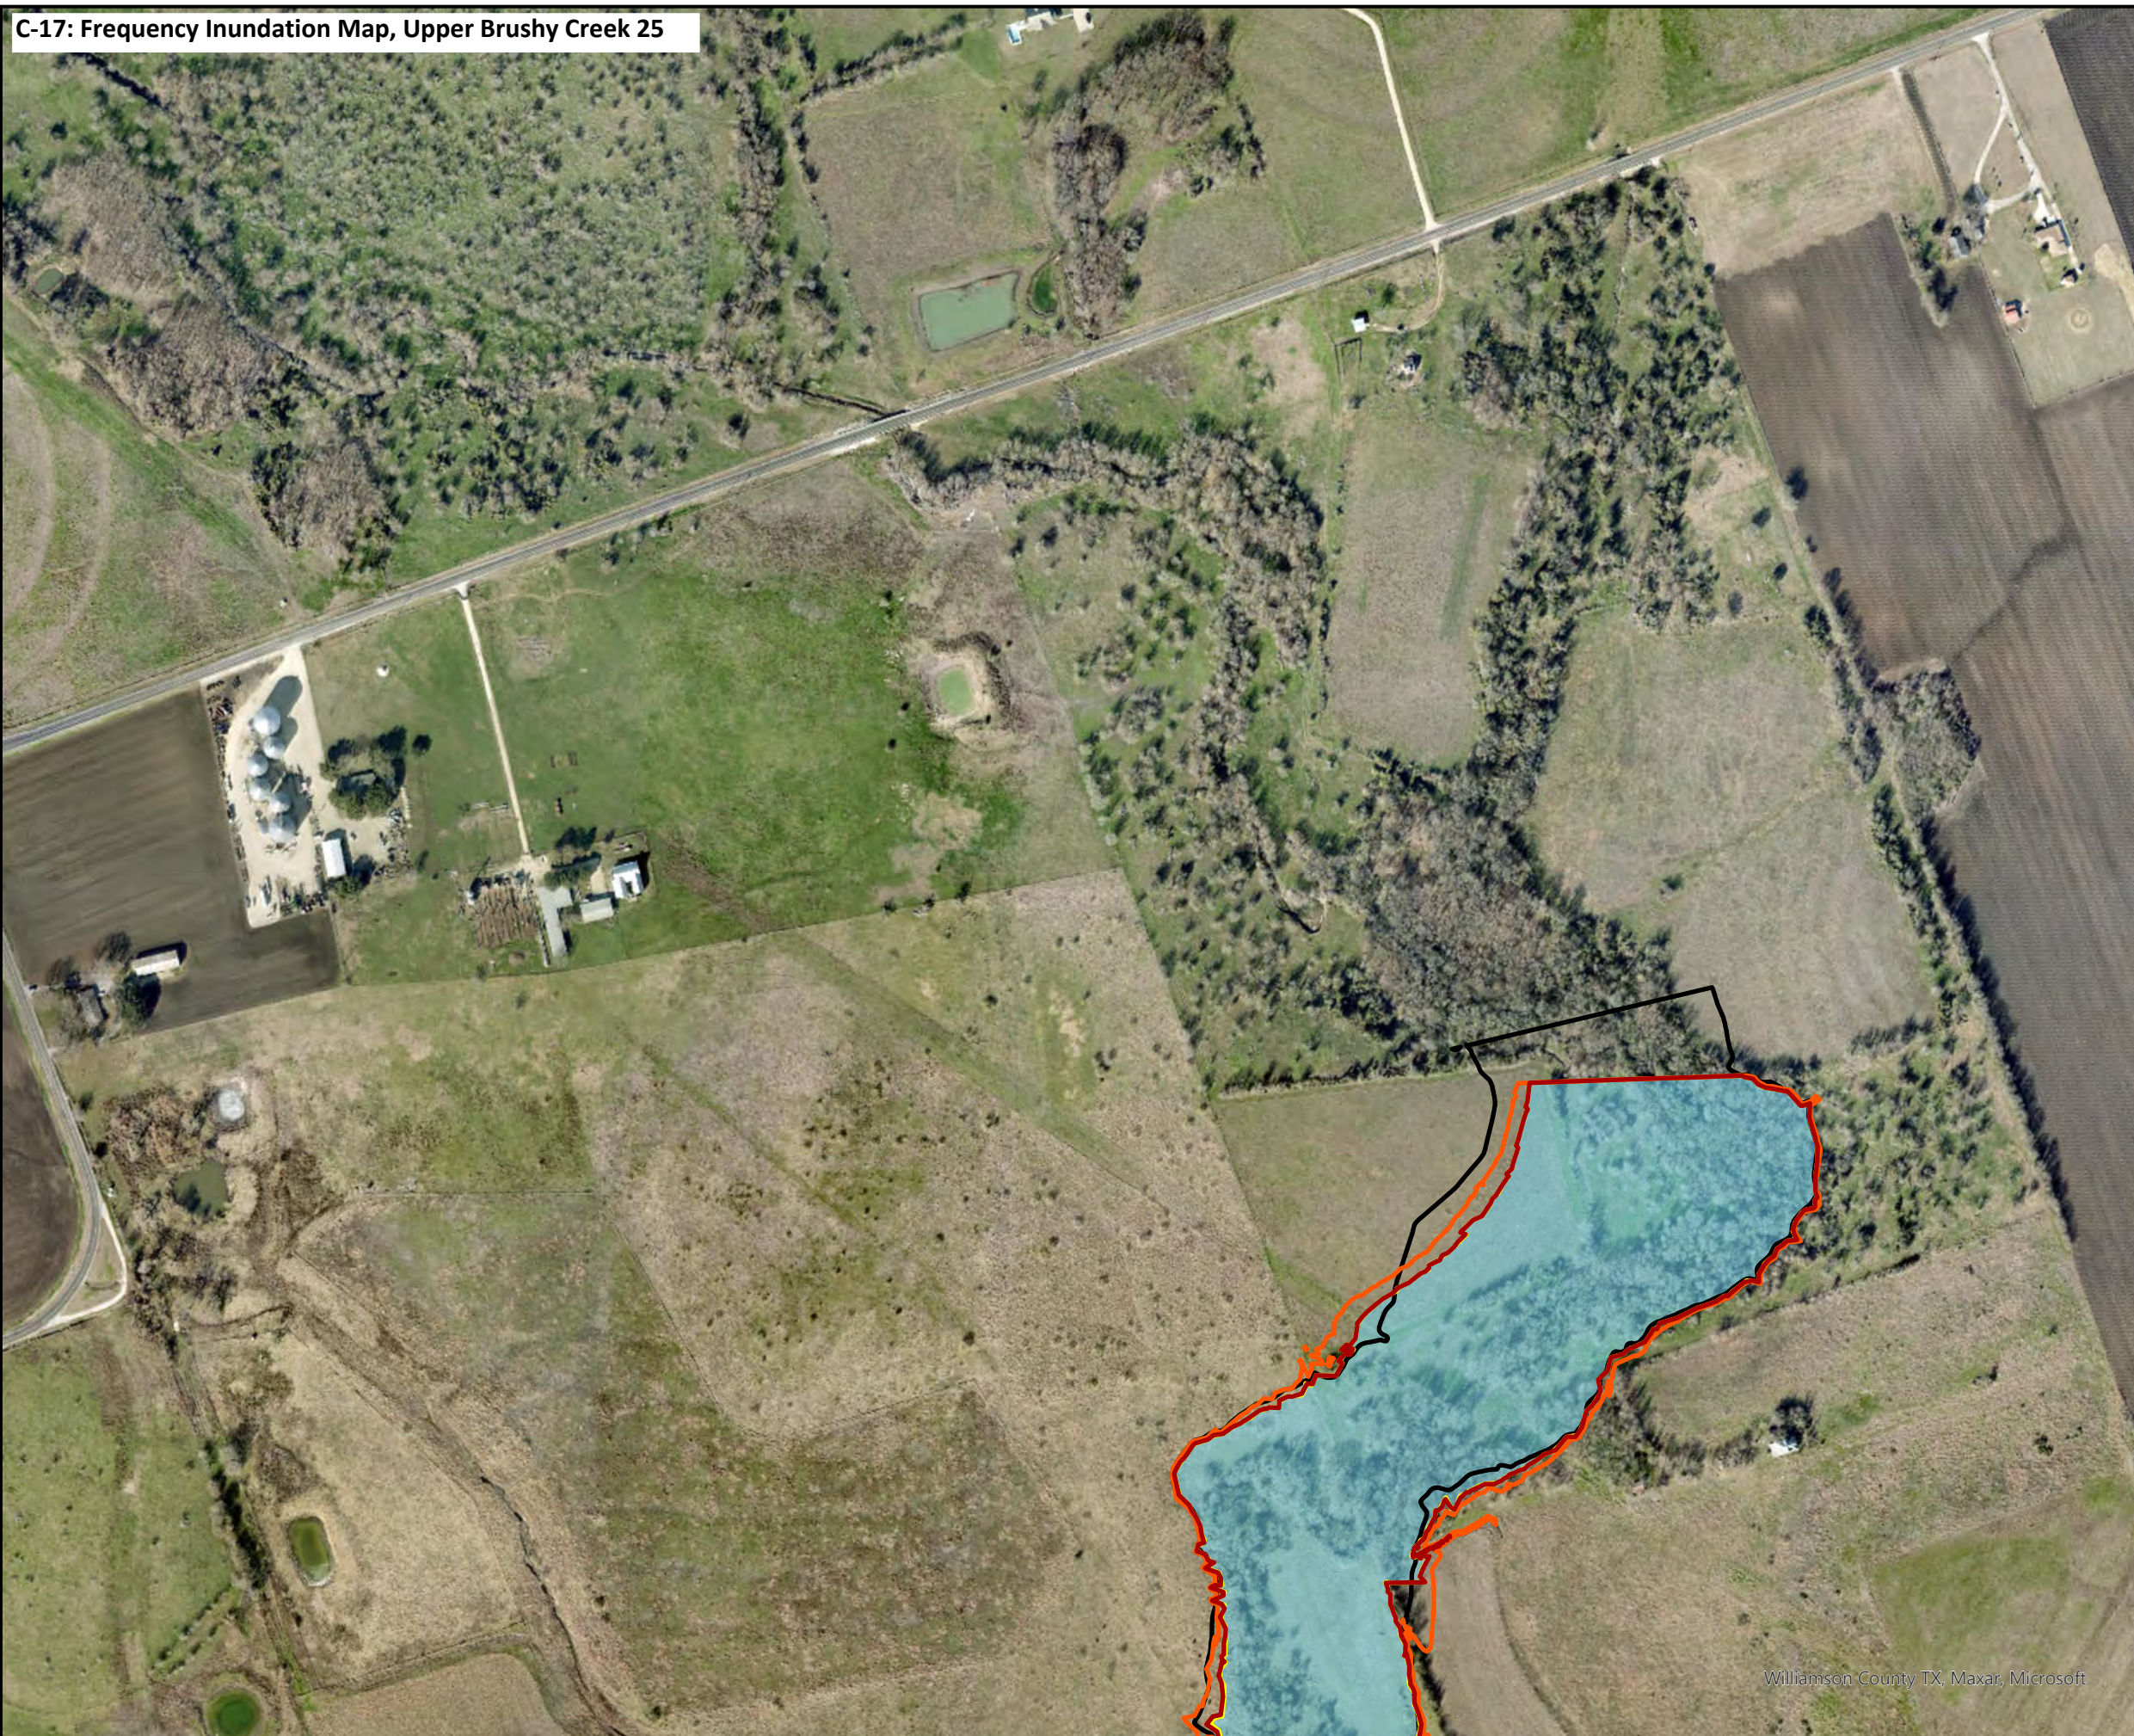
**UPPER BRUSHY CREEK 25  
FREQUENCY EVENTS  
INUNDATION MAP**  
Panel 3 of 12

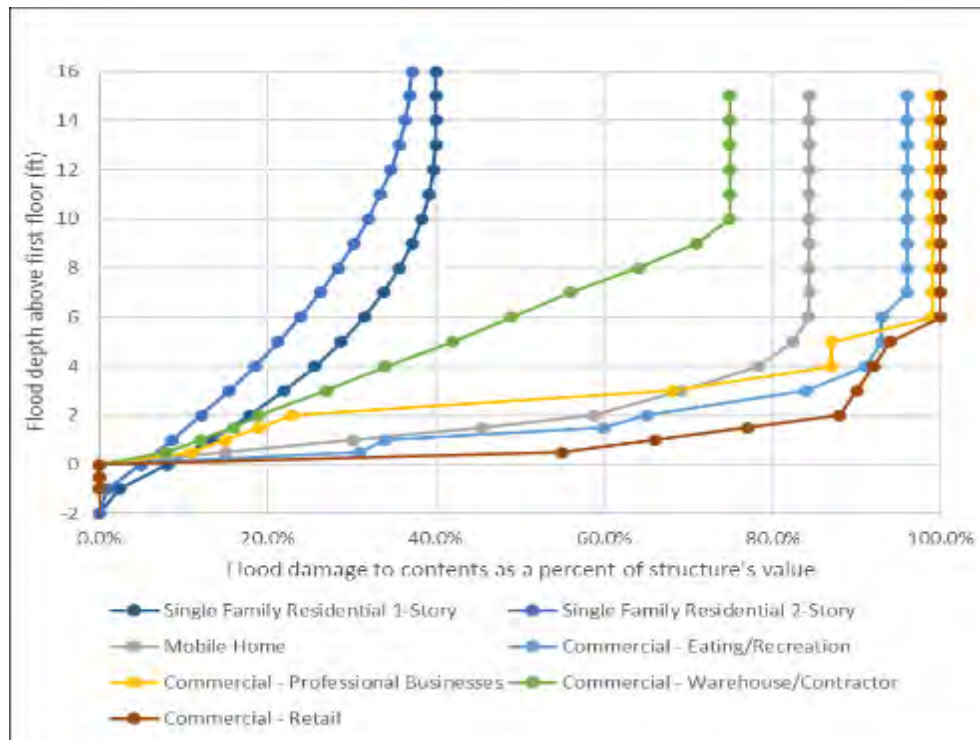
**Figure D-6 Contents Depth-Damage Curves**

The damages to contents were computed based on unique depth-damage curves for each structure, refer to Figure D-6.

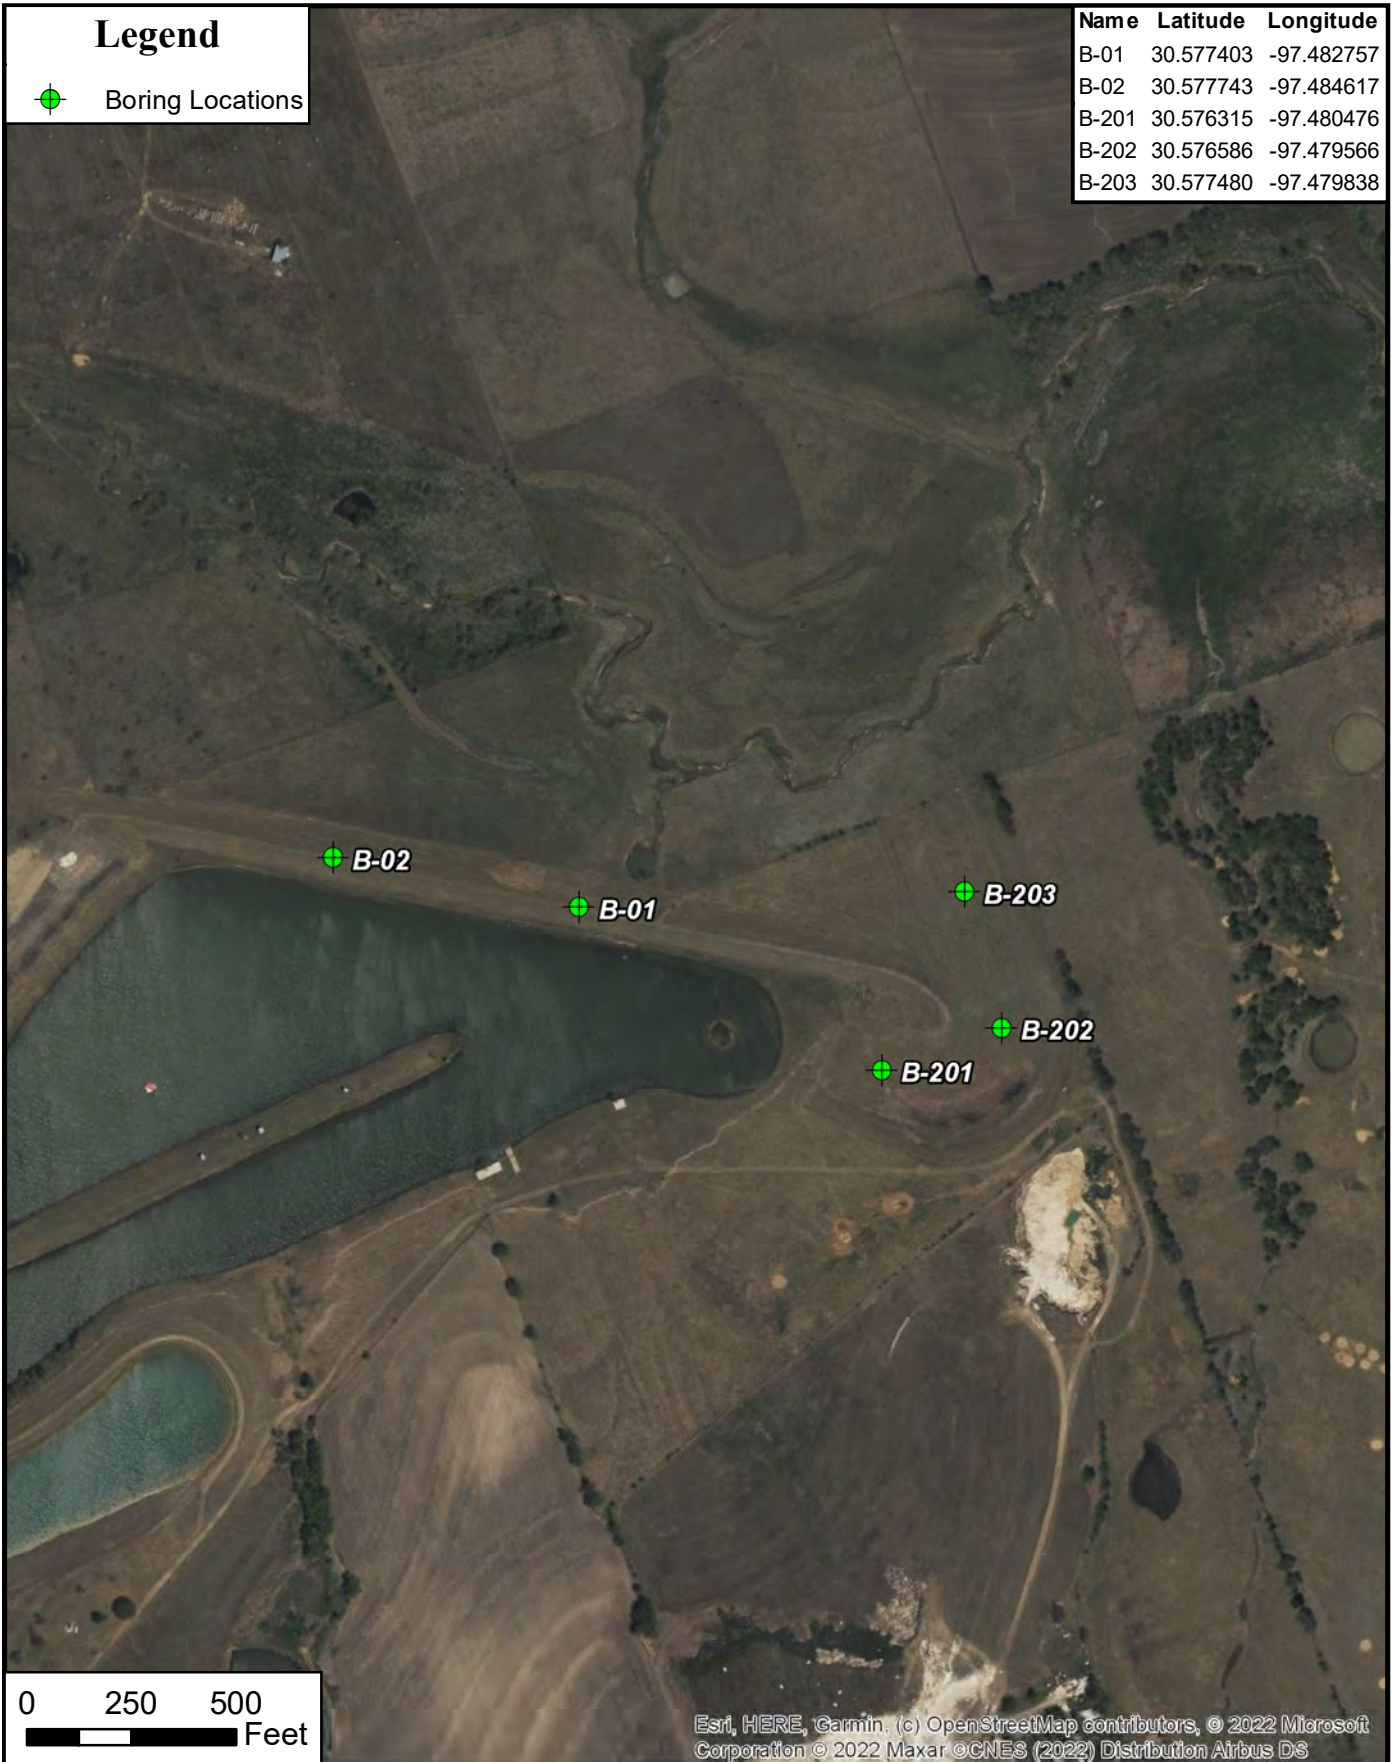
Boring Locations

Name	Latitude	Longitude
B-01	30.577403	-97.482757
B-02	30.577743	-97.484617
B-201	30.576315	-97.480476
B-202	30.576586	-97.479566
B-203	30.577480	-97.479838

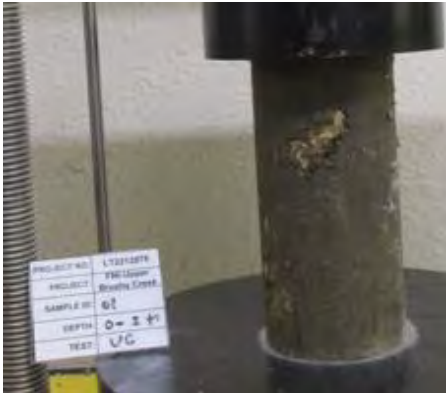
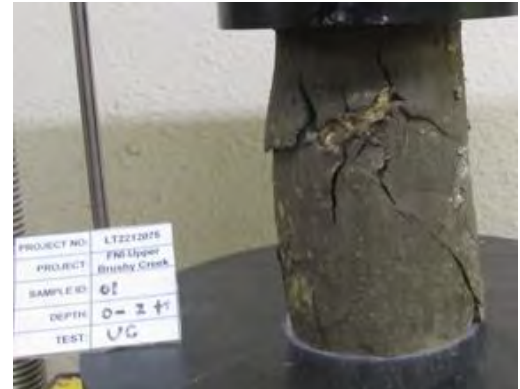
Client: Freese & Nichols, Inc.  
Project: Upper Brushy Creek #25  
(PN: TSW22726)  
Specimen: 01 at 0-2 ft

Project No.: LT2212075  
Test Method: ASTM D2166  
Test Date: 12/21/22

Failure Mode: Single Inclined Failure Plane

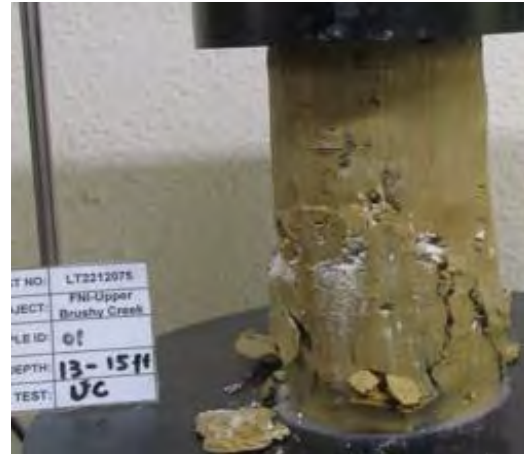
Client: Freese & Nichols, Inc.  
Project: Upper Brushy Creek #25  
(PN: TSW22726)  
Specimen: 01 at 13-15 ft

Project No.: LT2212075  
Test Method: ASTM D2166  
Test Date: 12/21/22

Failure Mode: Single Inclined Failure Plane

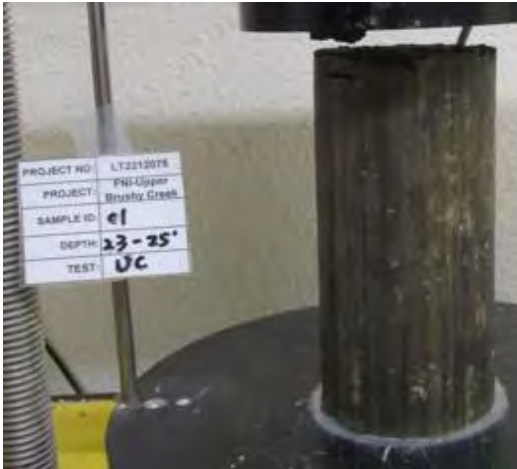
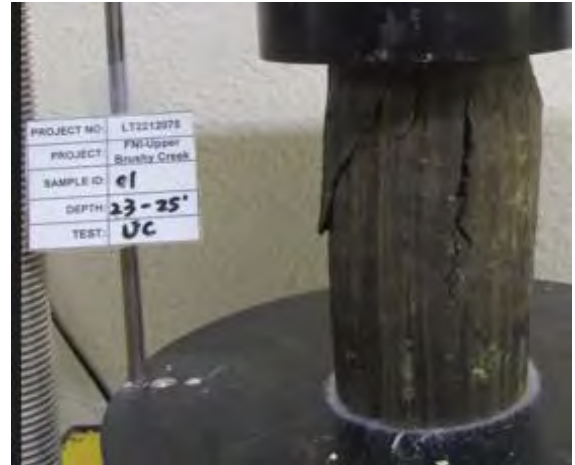
Client: Freese & Nichols, Inc.  
Project: Upper Brushy Creek #25  
(PN: TSW22726)  
Specimen: 01 at 23-25 ft

Project No.: LT2212075  
Test Method: ASTM D2166  
Test Date: 12/21/22

Failure Mode: Brittle Failure

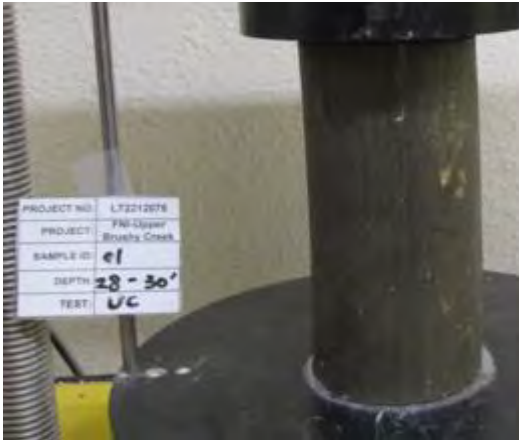
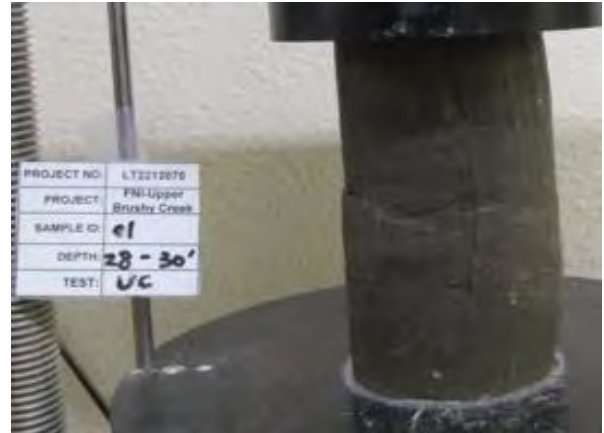
Client: Freese & Nichols, Inc.  
Project: Upper Brushy Creek #25  
(PN: TSW22726)  
Specimen: 01 at 28-30 ft

Project No.: LT2212075  
Test Method: ASTM D2166  
Test Date: 12/21/22

Failure Mode: Buldging

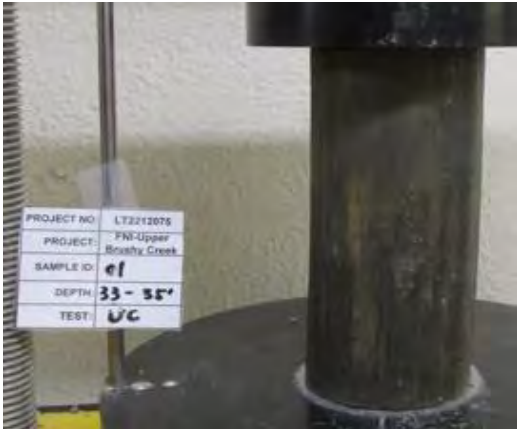
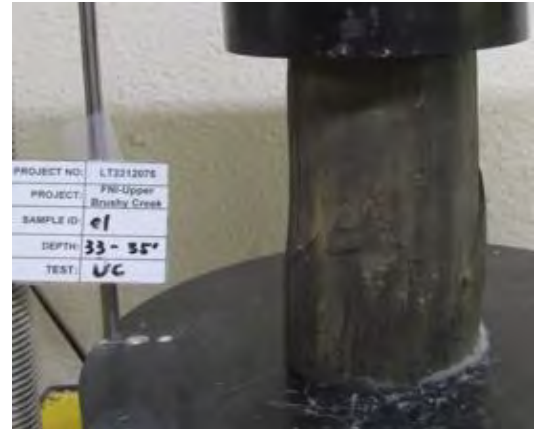
Client: Freese & Nichols, Inc.  
Project: Upper Brushy Creek #25  
(PN: TSW22726)  
Specimen: 01 at 33-35 ft

Project No.: LT2212075  
Test Method: ASTM D2166  
Test Date: 12/21/22

Failure Mode: Single Inclined Failure Plane

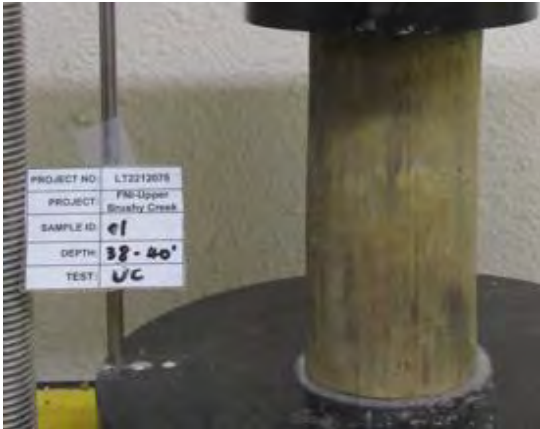
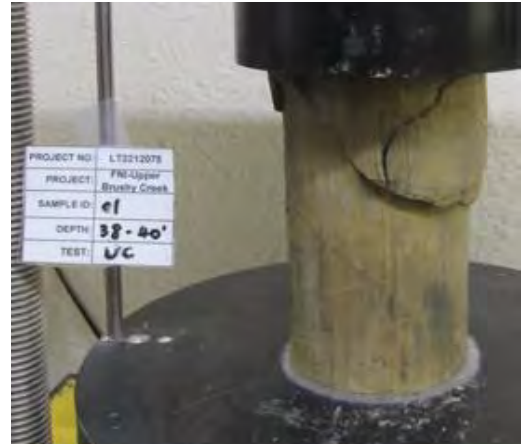
Client: Freese & Nichols, Inc.  
Project: Upper Brushy Creek #25  
(PN: TSW22726)  
Specimen: 01 at 38-40 ft

Project No.: LT2212075  
Test Method: ASTM D2166  
Test Date: 12/21/22

Failure Mode: Single Inclined Failure Plane

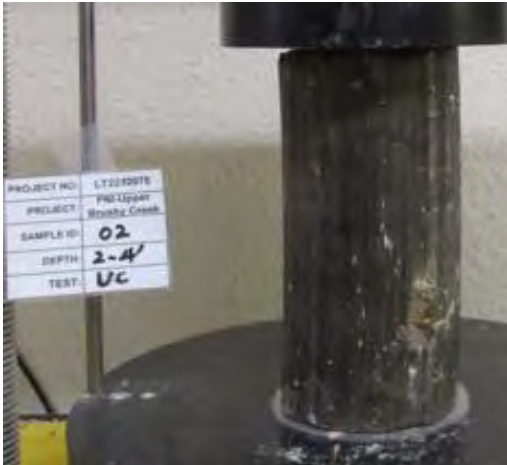
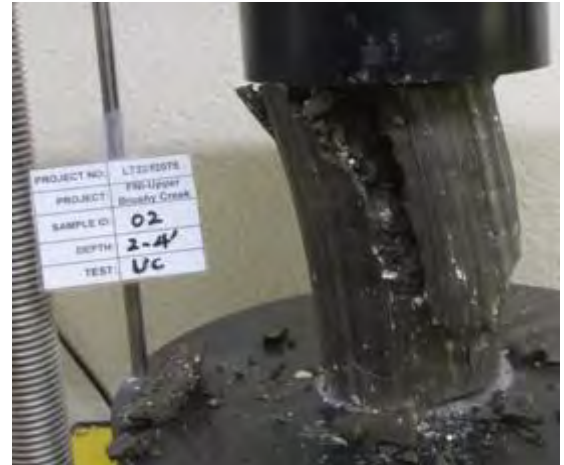
Client: Freese & Nichols, Inc.  
Project: Upper Brushy Creek #25  
(PN: TSW22726)  
Specimen: 02 at 2-4 ft

Project No.: LT2212075  
Test Method: ASTM D2166  
Test Date: 12/21/22

Failure Mode: Single Inclined Failure Plane

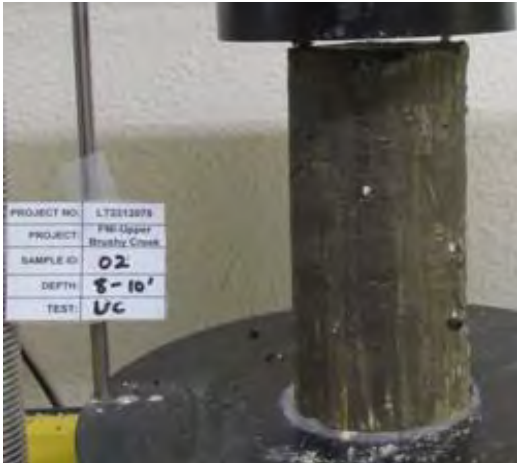
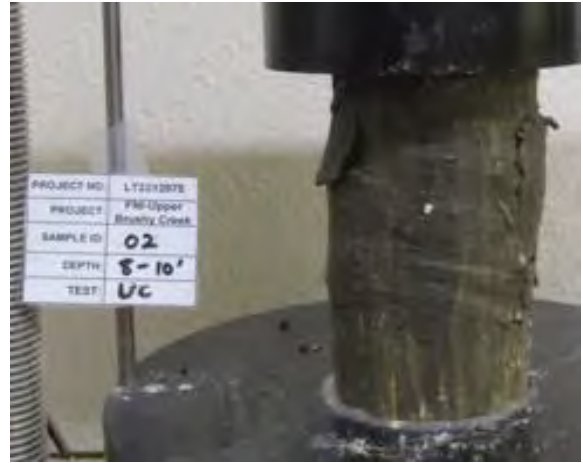
Client: Freese & Nichols, Inc.  
Project: Upper Brushy Creek #25  
(PN: TSW22726)  
Specimen: 02 at 8-10 ft

Project No.: LT2212075  
Test Method: ASTM D2166  
Test Date: 12/21/22

Failure Mode: Brittle Failure
