**SUPPLEMENTAL WATERSHED PLAN NO. VII &  
ENVIRONMENTAL ASSESSMENT  
FOR THE REHABILITATION OF FLOODWATER RETARDING STRUCTURE NO. 25  
OF THE UPPER BRUSHY CREEK WATERSHED**

**Prepared by:**  
U.S. Department of Agriculture  
Natural Resources Conservation Service

January 2025

**Draft**  
**Supplemental Watershed Plan No. VII and Environmental Assessment**  
**for the**  
**Rehabilitation of Floodwater retarding Structures No. 25**  
**of the**  
**Upper Brushy Creek Watershed**  
**Williamson County, Texas**

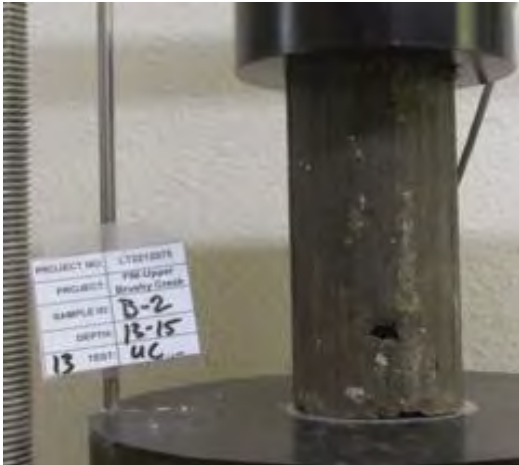
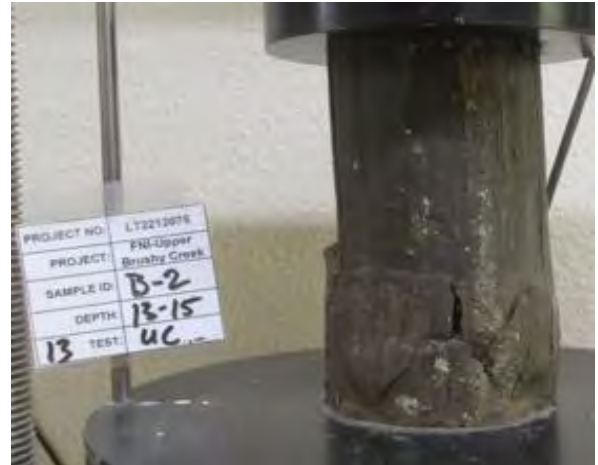
Client: Freese & Nichols, Inc.  
Project: Upper Brushy Creek #25  
(PN: TSW22726)  
Specimen: 02 at 13-15 ft

Project No.: LT2212075  
Test Method: ASTM D2166  
Test Date: 01/06/23

Failure Mode: Brittle Failure

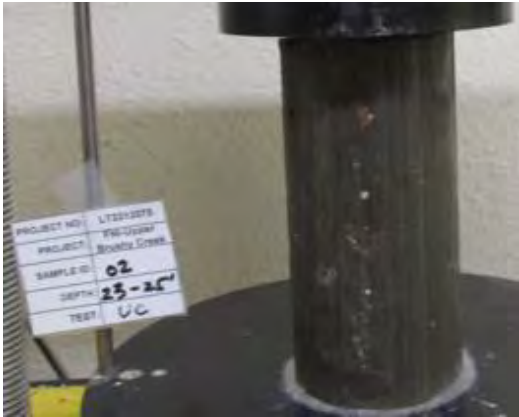
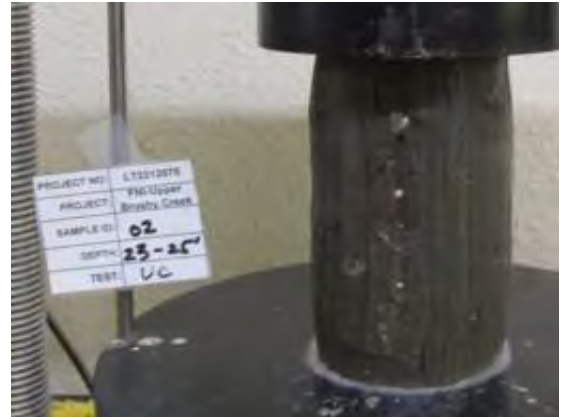
Client: Freese & Nichols, Inc.  
Project: Upper Brushy Creek #25  
(PN: TSW22726)  
Specimen: 02 at 23-25 ft

Project No.: LT2212075  
Test Method: ASTM D2166  
Test Date: 12/22/22

Failure Mode: Buldging

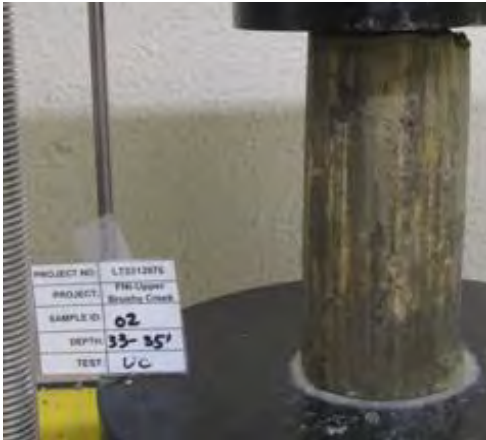
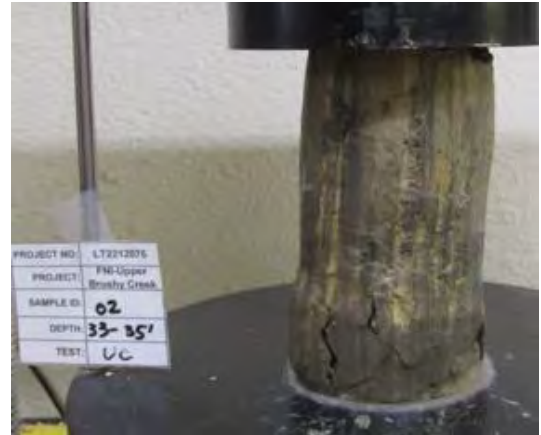
Client: Freese & Nichols, Inc.  
Project: Upper Brushy Creek #25  
(PN: TSW22726)  
Specimen: 02 at 33-35 ft

Project No.: LT2212075  
Test Method: ASTM D2166  
Test Date: 12/22/22

Failure Mode: Bulging

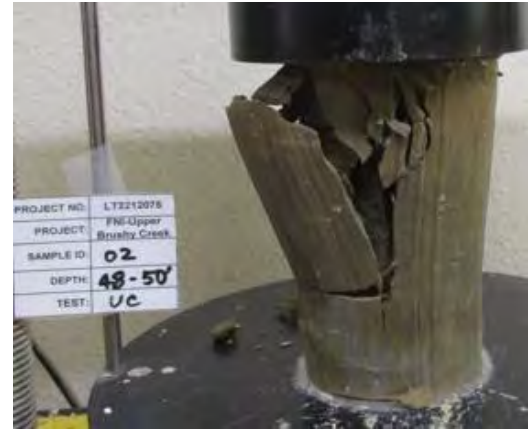
Client: Freese & Nichols, Inc.  
Project: Upper Brushy Creek #25  
(PN: TSW22726)  
Specimen: 02 at 48-50 ft

Failure Mode: Brittle Failure

Stresses at Failure	
Compressive Strength, $q_u$ (tsf)	0.9
Axial Strain at Failure (%)	7.6
Axial Strain at 50 % of $q_u$ (%)	1.2
Total Stresses at Failure	
Major Principal Stress, $S_1$ (psi)	12.8
Minor Principal Stress, $S_3$ (psi)	0
<b>Undrained Shear Strength, <math>S_u</math> (tsf)</b>	<b>0.46</b>

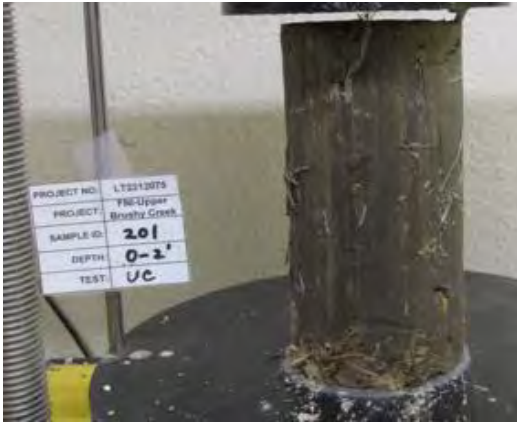
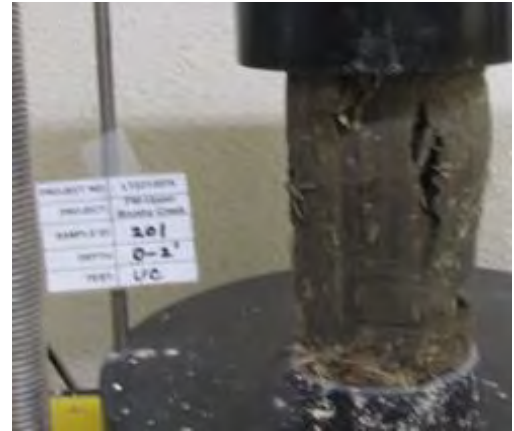
Client: Freese & Nichols, Inc.  
Project: Upper Brushy Creek #25  
(PN: TSW22726)  
Specimen: 201 at 0-2 ft

Failure Mode: Brittle Failure

Stresses at Failure	
Compressive Strength, $q_u$ (tsf)	1.8
Axial Strain at Failure (%)	14.8
Axial Strain at 50 % of $q_u$ (%)	2.0
Total Stresses at Failure	
Major Principal Stress, $S_1$ (psi)	25.5
Minor Principal Stress, $S_3$ (psi)	0
<b>Undrained Shear Strength, <math>S_u</math> (tsf)</b>	<b>0.92</b>

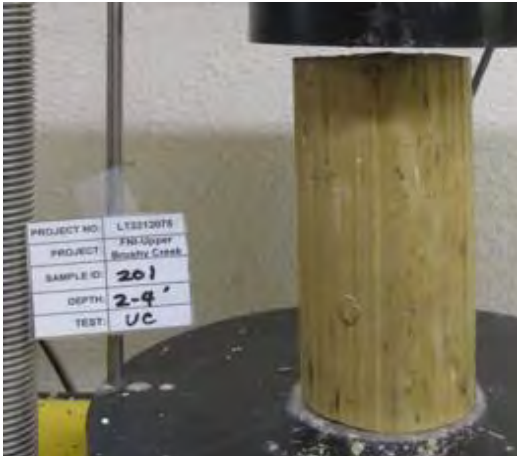
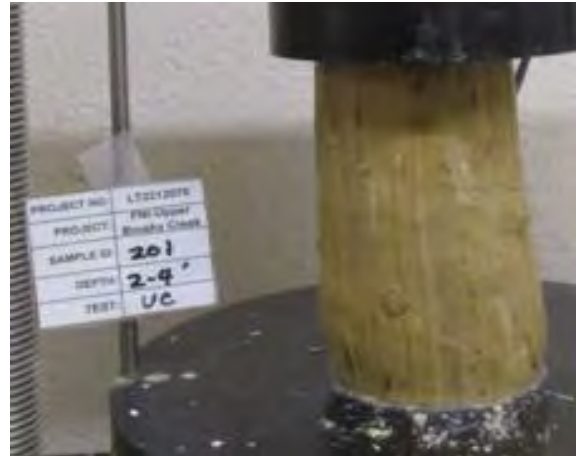
Client: Freese & Nichols, Inc.  
Project: Upper Brushy Creek #25  
(PN: TSW22726)  
Specimen: 201 at 2-4 ft

Failure Mode: Bulging

Stresses at Failure	
Compressive Strength, $q_u$ (tsf)	3.4
Axial Strain at Failure (%)	11.0
Axial Strain at 50 % of $q_u$ (%)	4.8
Total Stresses at Failure	
Major Principal Stress, $S_1$ (psi)	47.2
Minor Principal Stress, $S_3$ (psi)	0
<b>Undrained Shear Strength, <math>S_u</math> (tsf)</b>	<b>1.70</b>

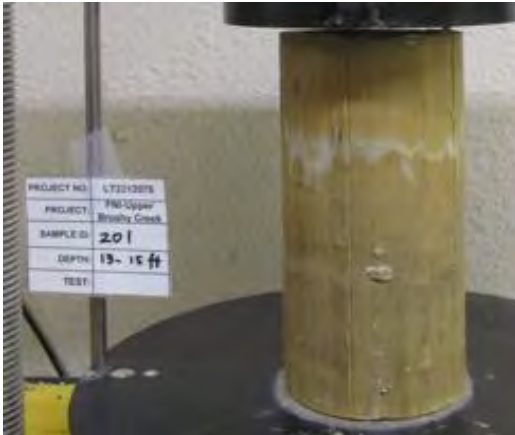
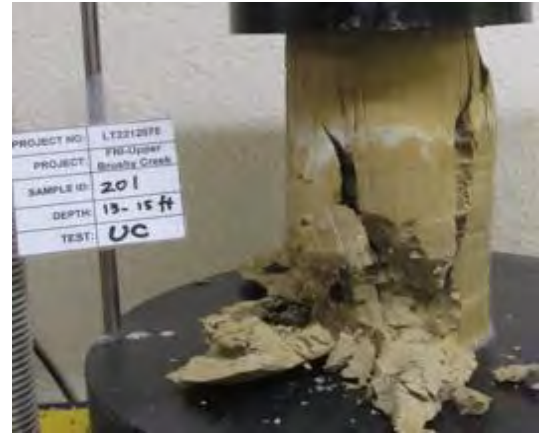
Client: Freese & Nichols, Inc.  
Project: Upper Brushy Creek #25  
(PN: TSW22726)  
Specimen: 201 at 13-15 ft

Failure Mode: Brittle Failure

Stresses at Failure	
Compressive Strength, $q_u$ (tsf)	2.0
Axial Strain at Failure (%)	7.8
Axial Strain at 50 % of $q_u$ (%)	2.2
Total Stresses at Failure	
Major Principal Stress, $S_1$ (psi)	28.3
Minor Principal Stress, $S_3$ (psi)	0
<b>Undrained Shear Strength, <math>S_u</math> (tsf)</b>	<b>1.02</b>

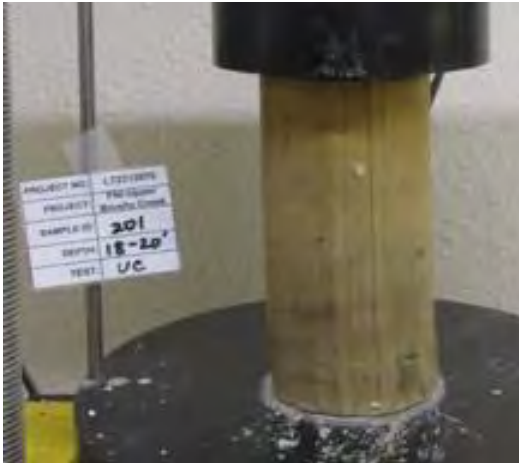
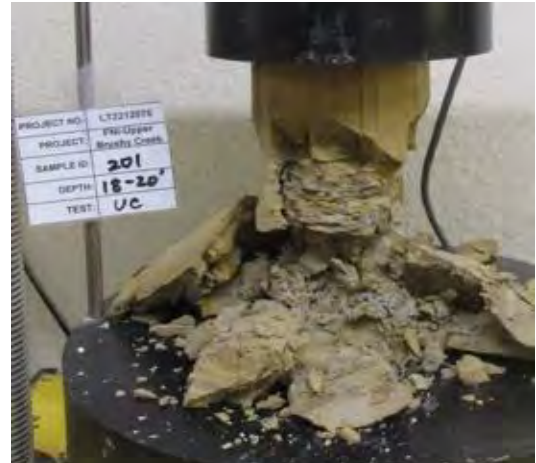
Client: Freese & Nichols, Inc.  
Project: Upper Brushy Creek #25  
(PN: TSW22726)  
Specimen: 201 at 18-20 ft

Failure Mode: Brittle Failure

Stresses at Failure	
Compressive Strength, $q_u$ (tsf)	0.5
Axial Strain at Failure (%)	3.7
Axial Strain at 50 % of $q_u$ (%)	0.9
Total Stresses at Failure	
Major Principal Stress, $S_1$ (psi)	7.4
Minor Principal Stress, $S_3$ (psi)	0
<b>Undrained Shear Strength, <math>S_u</math> (tsf)</b>	<b>0.27</b>

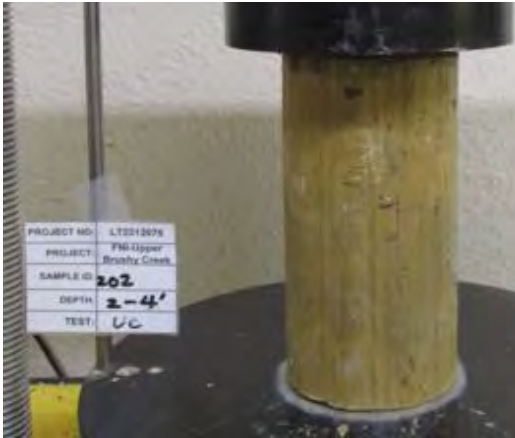
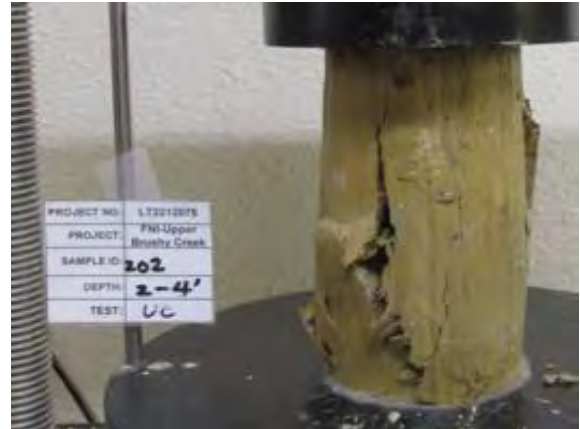
Client: Freese & Nichols, Inc.  
Project: Upper Brushy Creek #25  
(PN: TSW22726)  
Specimen: 202 at 2-4 ft

Failure Mode: Brittle Failure

Initial Specimen Conditions		
Avg. Diameter (in)	D <sub>o</sub>	2.71
Avg. Height (in)	H <sub>o</sub>	5.79
Water Content (%)	w <sub>o</sub>	25.6
Total Unit Weight (pcf)	γ <sub>total</sub>	113.3
Dry Unit Weight (pcf)	γ <sub>dry</sub>	90.2
Saturation (%)	S <sub>r</sub>	79.5
Void Ratio	e <sub>o</sub>	0.87
Specific Gravity (Assumed)	G <sub>s</sub>	2.70

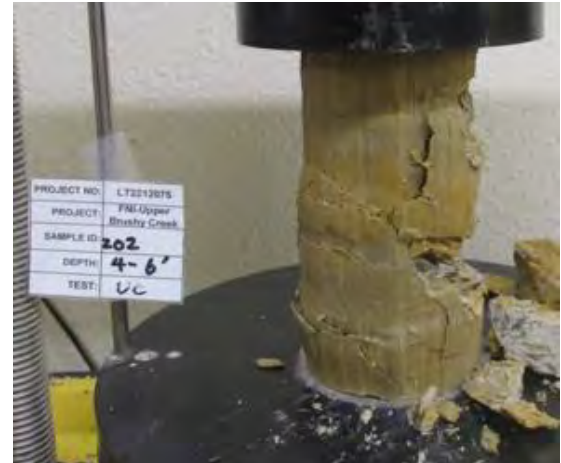
Client: Freese & Nichols, Inc.  
Project: Upper Brushy Creek #25  
(PN: TSW22726)  
Specimen: 202 at 4-6 ft

Failure Mode: Diagonal Failure Plane (Transition)

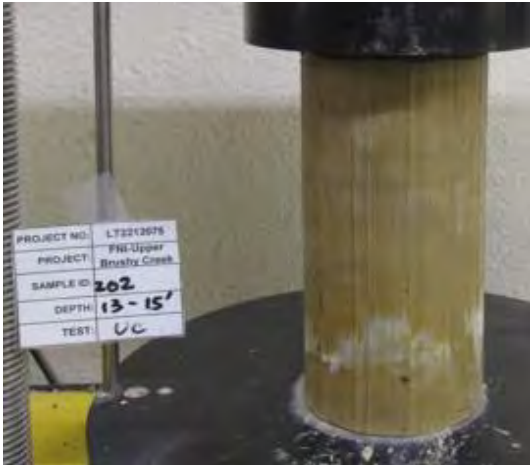
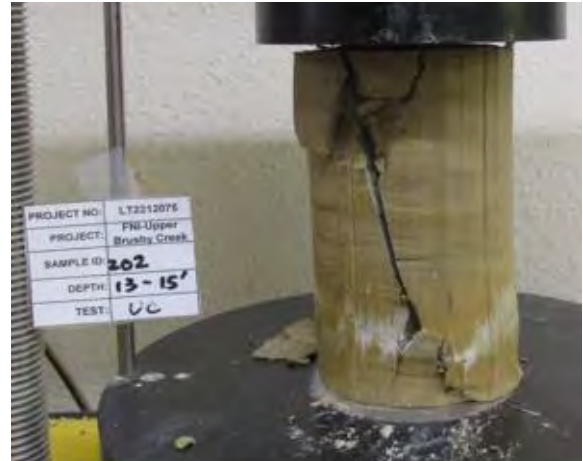
Client: Freese & Nichols, Inc.  
Project: Upper Brushy Creek #25  
(PN: TSW22726)  
Specimen: 202 at 13-15 ft

Failure Mode: Single Inclined Failure Plane

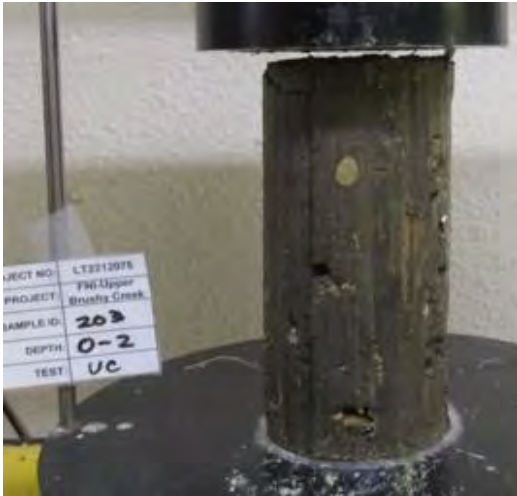
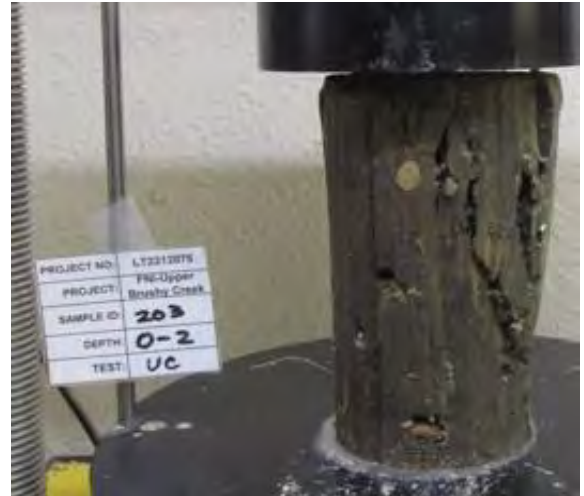
Client: Freese & Nichols, Inc.  
Project: Upper Brushy Creek #25  
(PN: TSW22726)  
Specimen: 203 at 0-2 ft

Failure Mode: Brittle Failure

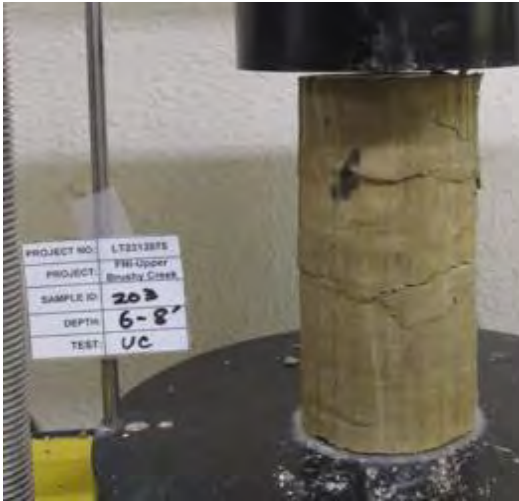
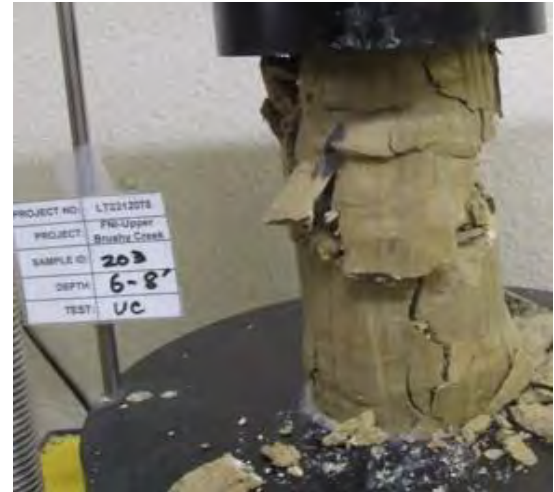
Client: Freese & Nichols, Inc.  
Project: Upper Brushy Creek #25  
(PN: TSW22726)  
Specimen: 203 at 6-8 ft

Failure Mode: Brittle Failure

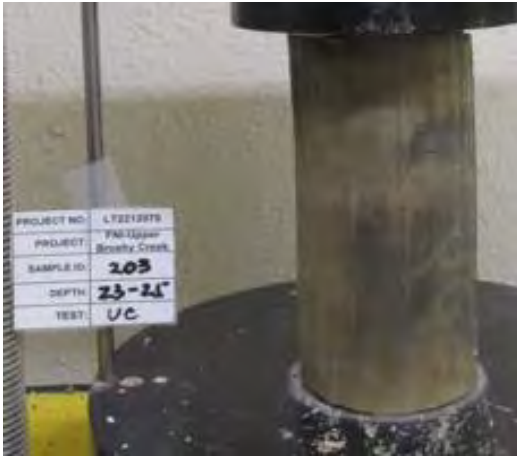
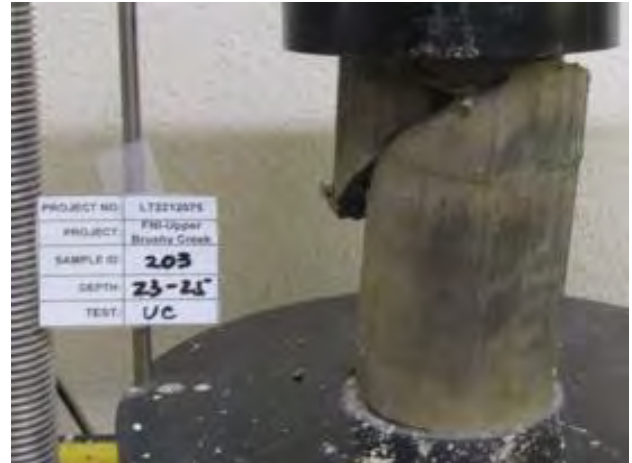
Client: Freese & Nichols, Inc.  
Project: Upper Brushy Creek #25  
(PN: TSW22726)  
Specimen: 203 at 23-25 ft

Failure Mode: Single Inclined Failure Plane

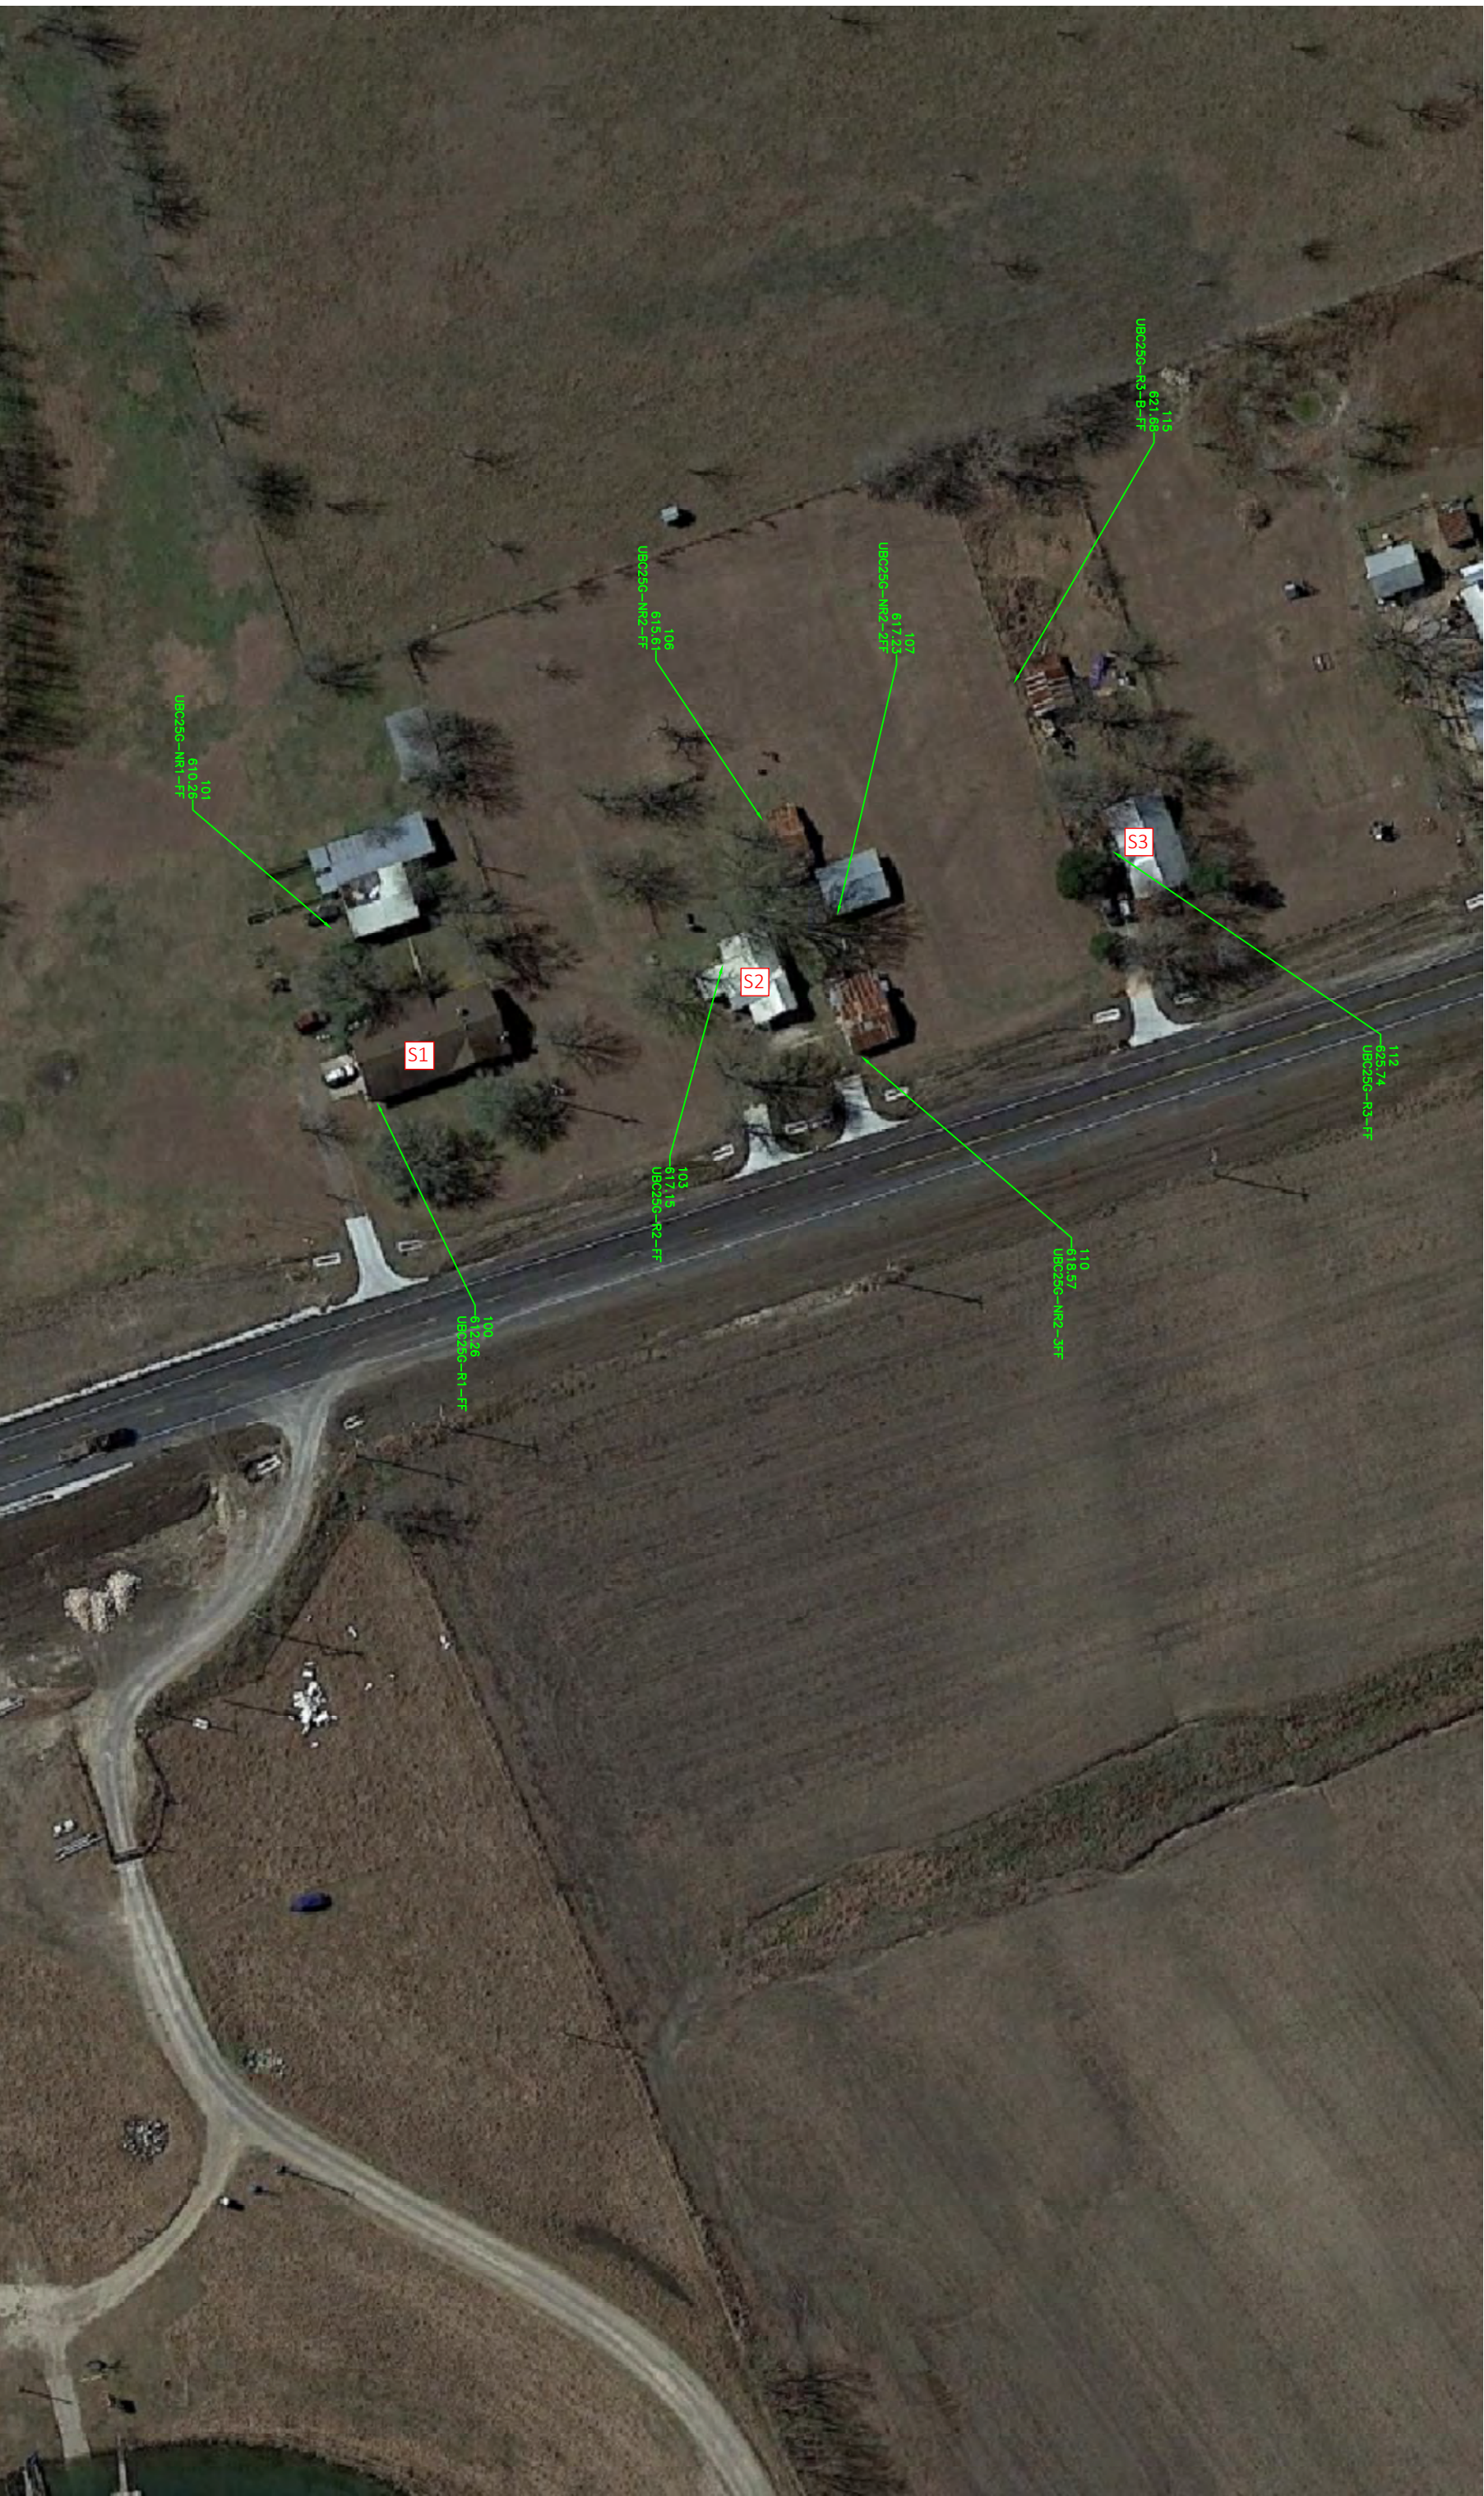
Attachment E-8: Survey Data for Structures Located Upstream of  
Upper Brushy Creek 25

UBC250-R3-B-FF  
621.68  
118

UBC250-NR2-2FF  
617.23  
107
